# 624 East Ohio Street – Historic Designation Removal

September 08, 2026

Urban  
Redevelopment  
Authority  
of Pittsburgh

# Brace Engineering: Structural Review Findings

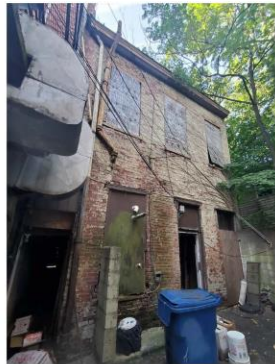
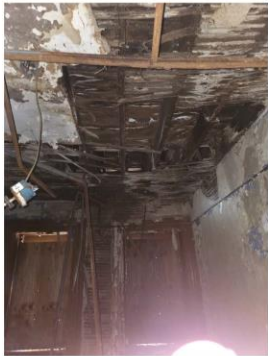
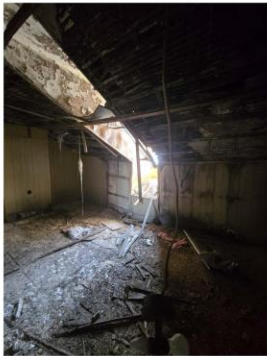
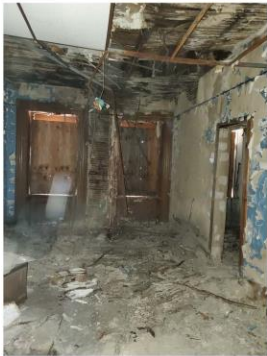
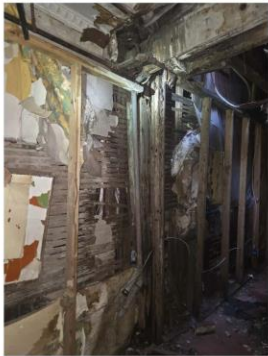
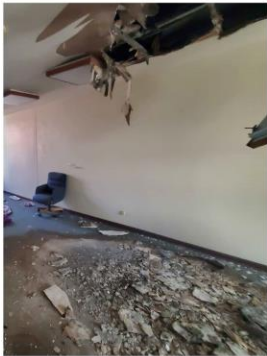
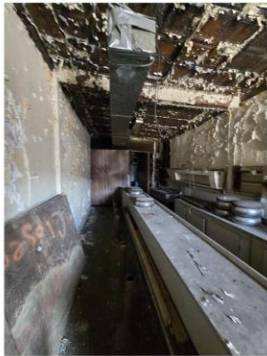
2 Interior Existing Conditions  
MP-02 Scale: Actual Size

- Severe sagging of interior tin ceilings due to prolonged retention.
- Widespread mold growth and active rot in primary framing.
- Roof, gutter, and downspout failures causing progressive collapse.
