TECHNICAL MEMORANDUM

Homewood Active Mobility Improvements

Safety Study Memo

Date:	June 21, 2021	Project #:	24234.001
To:	Department of Mobility and Infrastructure (DOMI)		
From:	Lauren Ahramjian, Jamie Henson, Lauren Hunt, and Alexandra Jahnle		
cc:	Panini Chowdhury

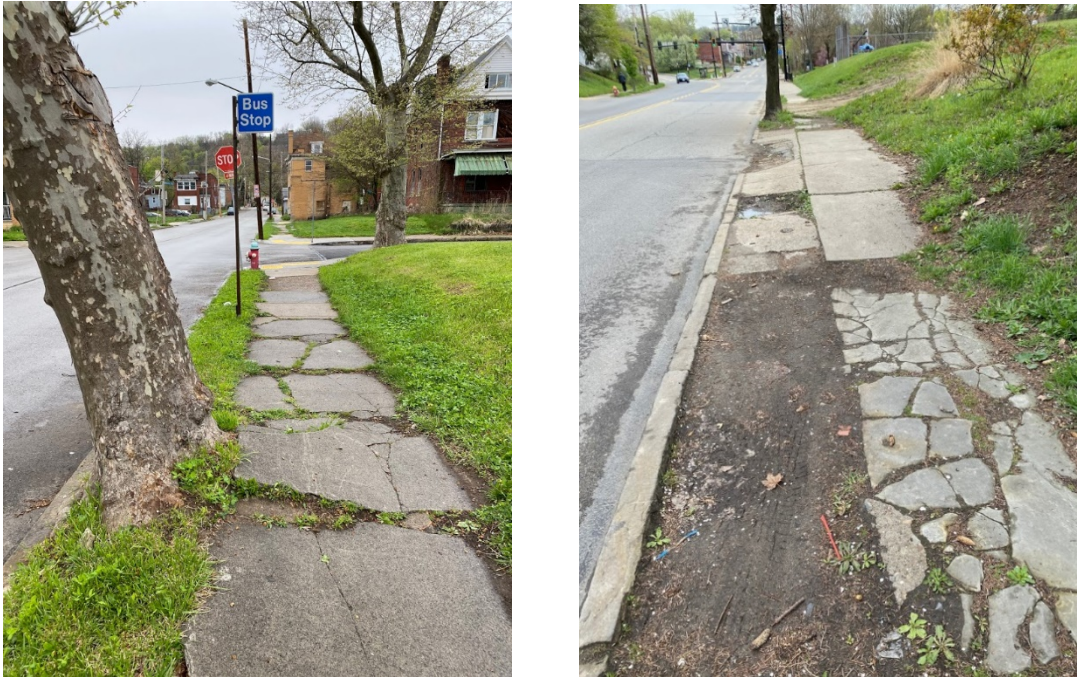
Conditions in the study area included numerous broken sidewalks and faded pavement markings. **Figure 7** and **Figure 8** show sidewalk conditions and faded pavement markings observed during the site visit. Sidewalk conditions will be inventoried in greater detail in the Task 2 report.

Figure 7: Poor Sidewalk Conditions in Homewood

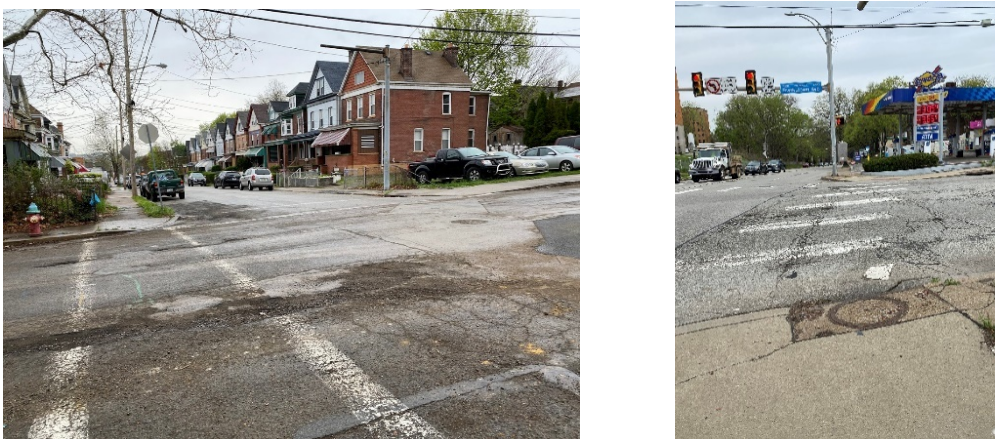
Figure 8: Faded Pavement Markings in Homewood

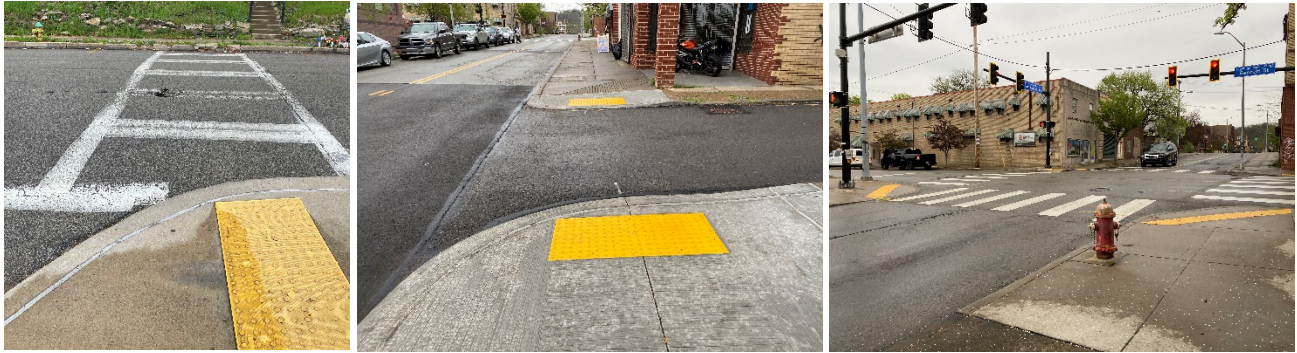
Many intersections have ADA accessible ramps at the intersections, even if a sidewalk is currently not present leading to the ramp. In addition, some locations only have a ramp on one side. **Figure 9** displays some of these ramps.

Figure 9: Study Area Ramps

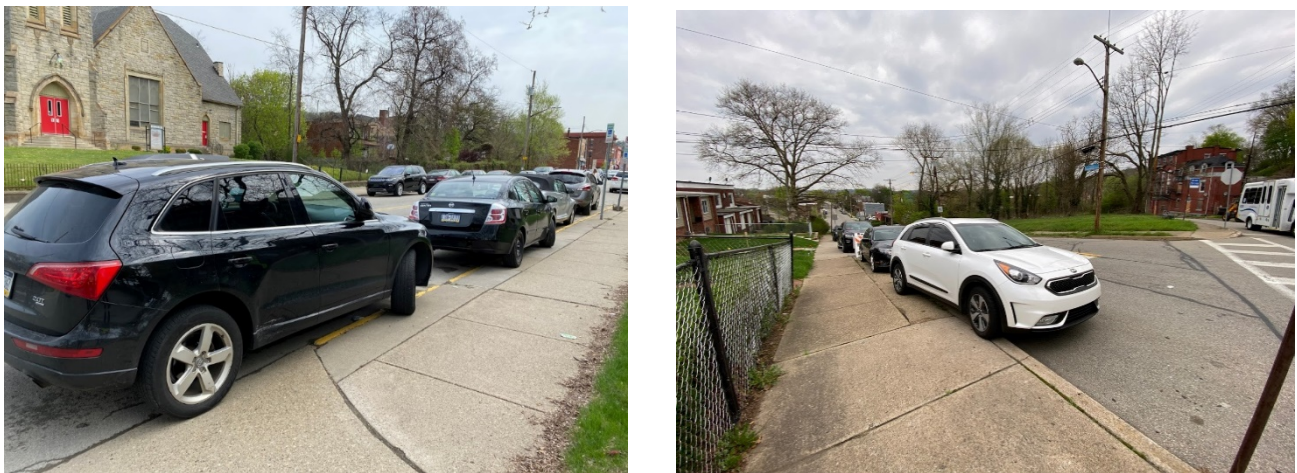
Many streets have cars parked on the sidewalks as shown in **Figure 10**. This may be a result of residents not being comfortable using the parking lane due to high speed neighborhood traffic and subsequent clipping of side mirrors.,

Figure 10: Parking in Homewood

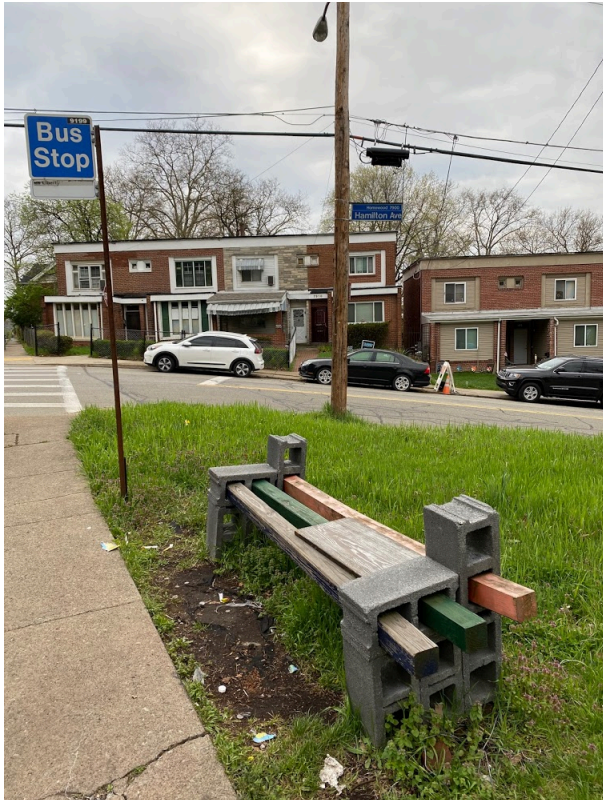
Transit stops are mainly limited to bus stops without shelters throughout the study area. There may be a further demand in some locations for more stops, as evidenced by make-shift benches by the local community, like the one on Hamilton Avenue/Oakwood Street/Havenhill Street shown in **Figure 11**. Some bus stations also were damaged in the study area, like the one shown in **Figure 12** with a missing panel.

Figure 11: Community Created Bus Stop

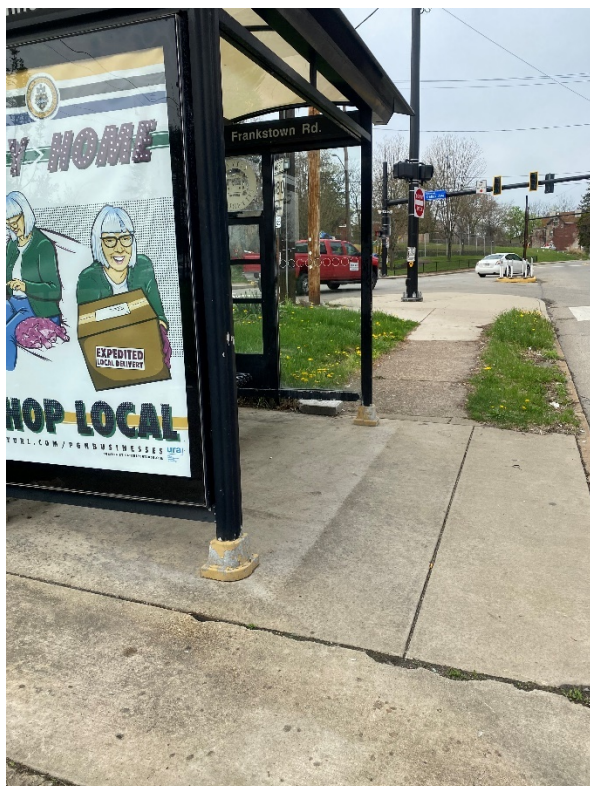
Figure 12: Bus Stop at Dallas Avenue and Frankstown Avenue

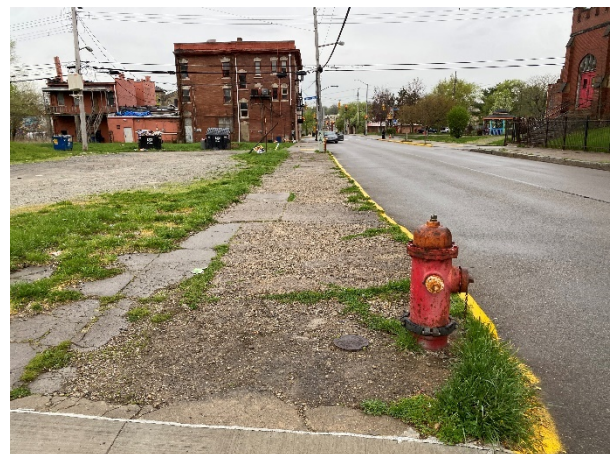
Figure 18: Sidewalks on Homewood Avenue

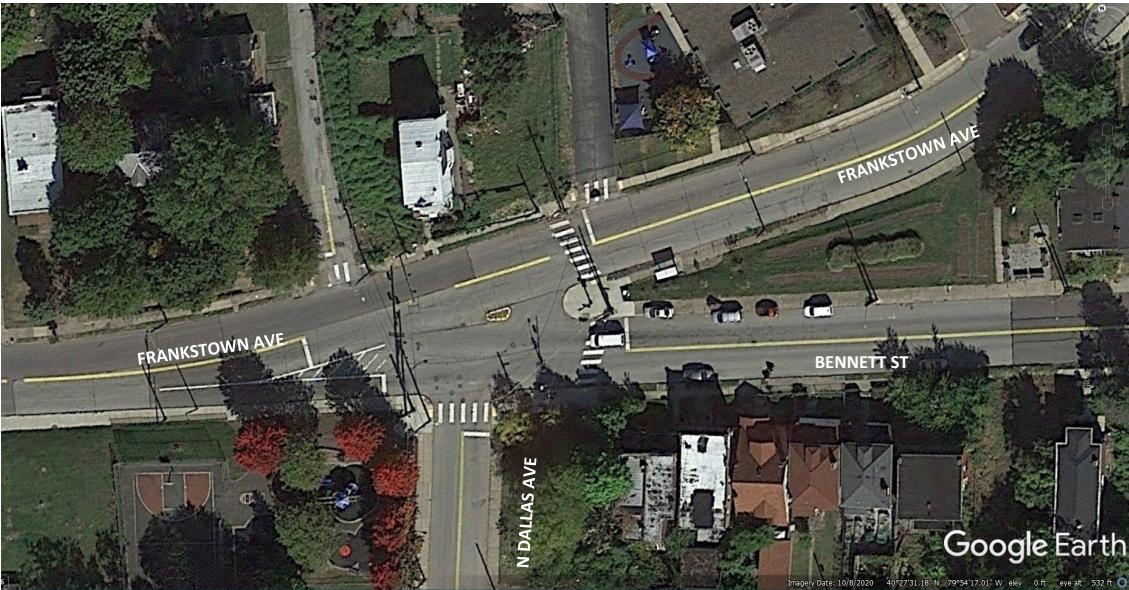
Figure 20. Frankstown Avenue/ Bennett Street/ Dallas Street Intersection Aerial

<ul style="list-style-type: none"> Five crashes occurred at this intersection (two (2) rear end, one (1) head on, and two (2) hit fixed object) which may be a result of the current configuration of the roadway geometry and confusing vehicular movements. 	Evaluate roadway geometry
	<ul style="list-style-type: none"> Signal equipment appears to be recently upgraded. The orange "Don't Walk" pedestrian signal located between Frankstown and Bennett is not working for pedestrians walking northbound across the Bennett leg of the intersection. 	Fix pedestrian signal.
	<ul style="list-style-type: none"> Old utility poles at the intersection that have a white spray painted "X" on them that could be removed. 	Remove old utility pole.
Frankstown Avenue / Gerritt Street Curve	<ul style="list-style-type: none"> No visible pavement markings (crosswalk or stop bar) at the Gerritt Street intersection. An aerial view of the Frankstown/Gerritt curve is displayed in Figure 21. 	Paint stop bars and High Visibility crosswalks.

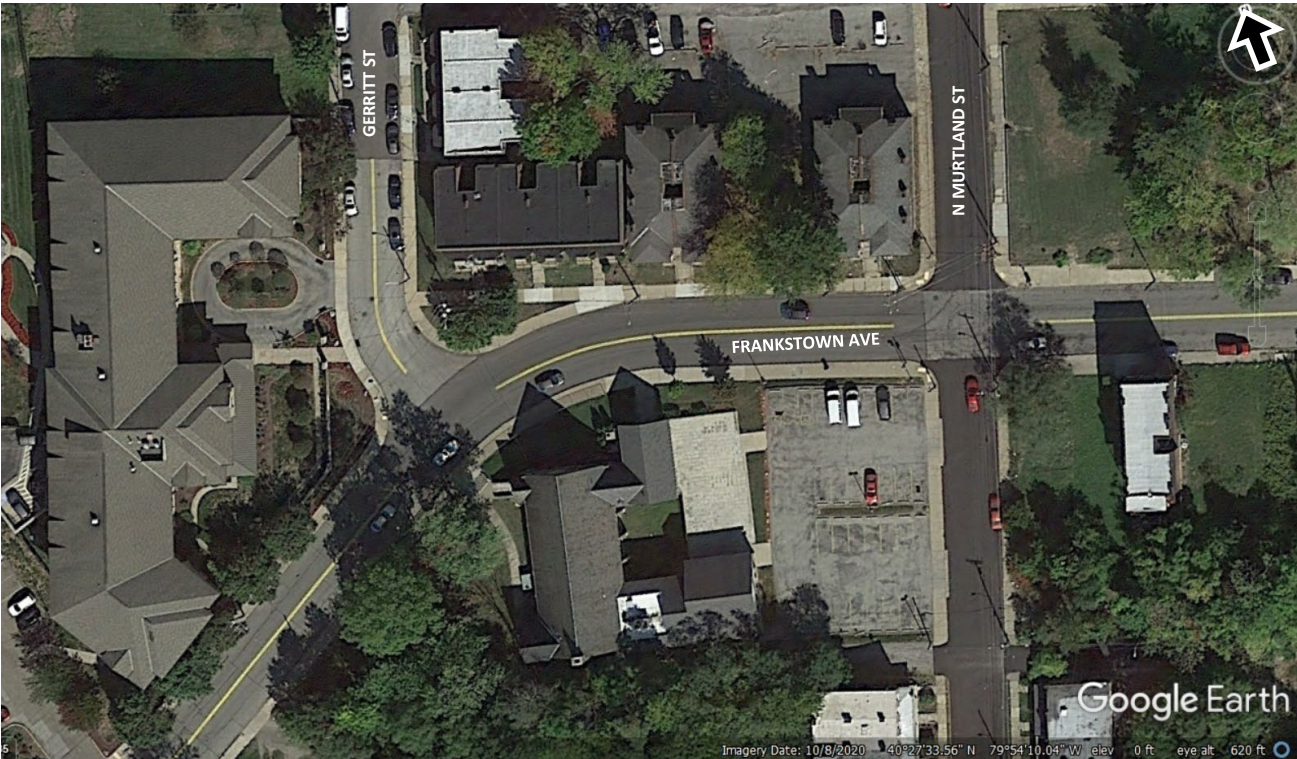
Figure 21. Frankstown Avenue/ Gerritt Street Curve Aerial

<ul style="list-style-type: none"> Seven (7) hit fixed object crashes occurred at the Frankstown/Gerritt curve, one (1) of which was a fatality. Poor vehicle sightline visibility at the curve 	<p>Install daylighting along the curve and at the Gerritt St intersection to enhance visibility for pedestrians and vehicles.</p> <p>Paint parking lane lines to visually narrow the wide travel lanes and to hatch out an area for Sunday only church parking on the south side of the curve.</p>
Murtland/ Frankstown Intersection	<ul style="list-style-type: none"> Old signal equipment. No pedestrian signals or pushbuttons at this intersection. 	Upgrade signal equipment.

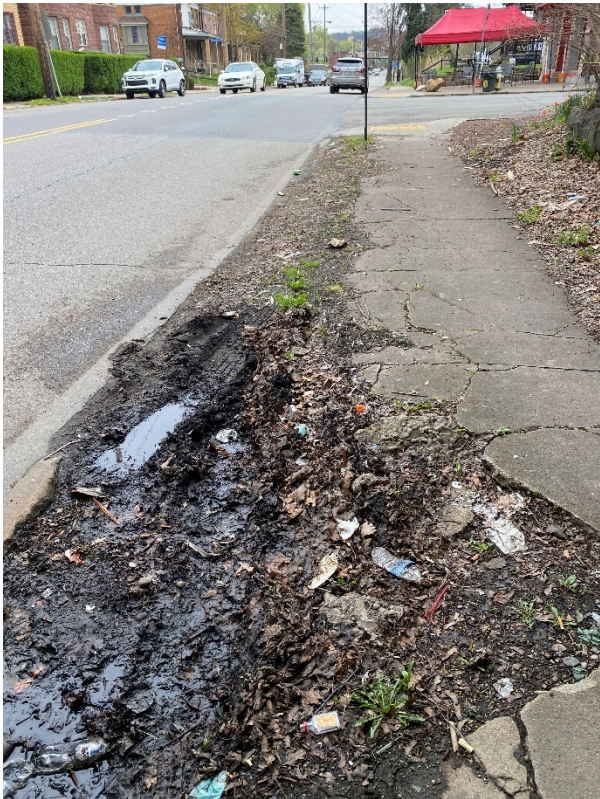
Figure 23: Sidewalk on Frankstown Avenue

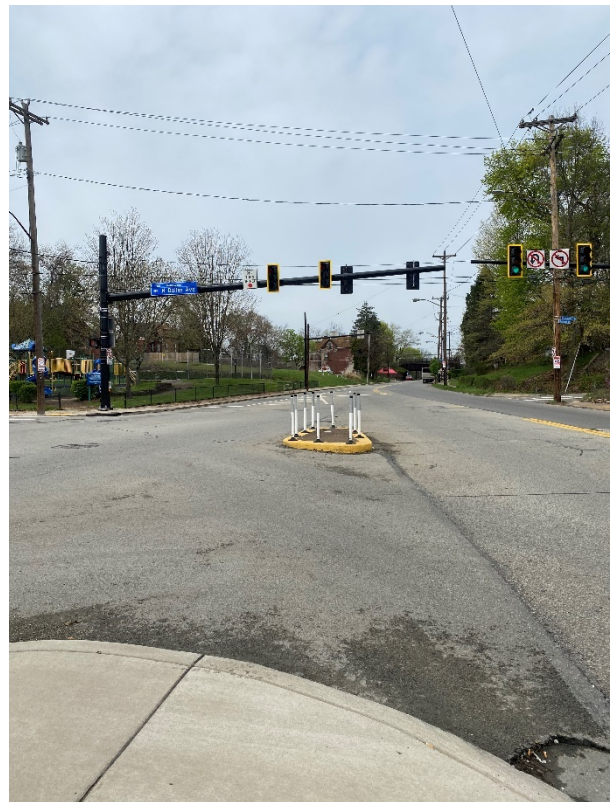
Figure 25: Dallas/Frankstown Intersection
