7.DCP-ZDR-2025-00274

1250 Liverpool Street

CHURCH DEMOLITION

Subject: Manchester Academic Charter School
Structural Assessment of Existing Building – 1250 Liverpool Street, Pittsburgh, PA
TSE Proposal No. 7822

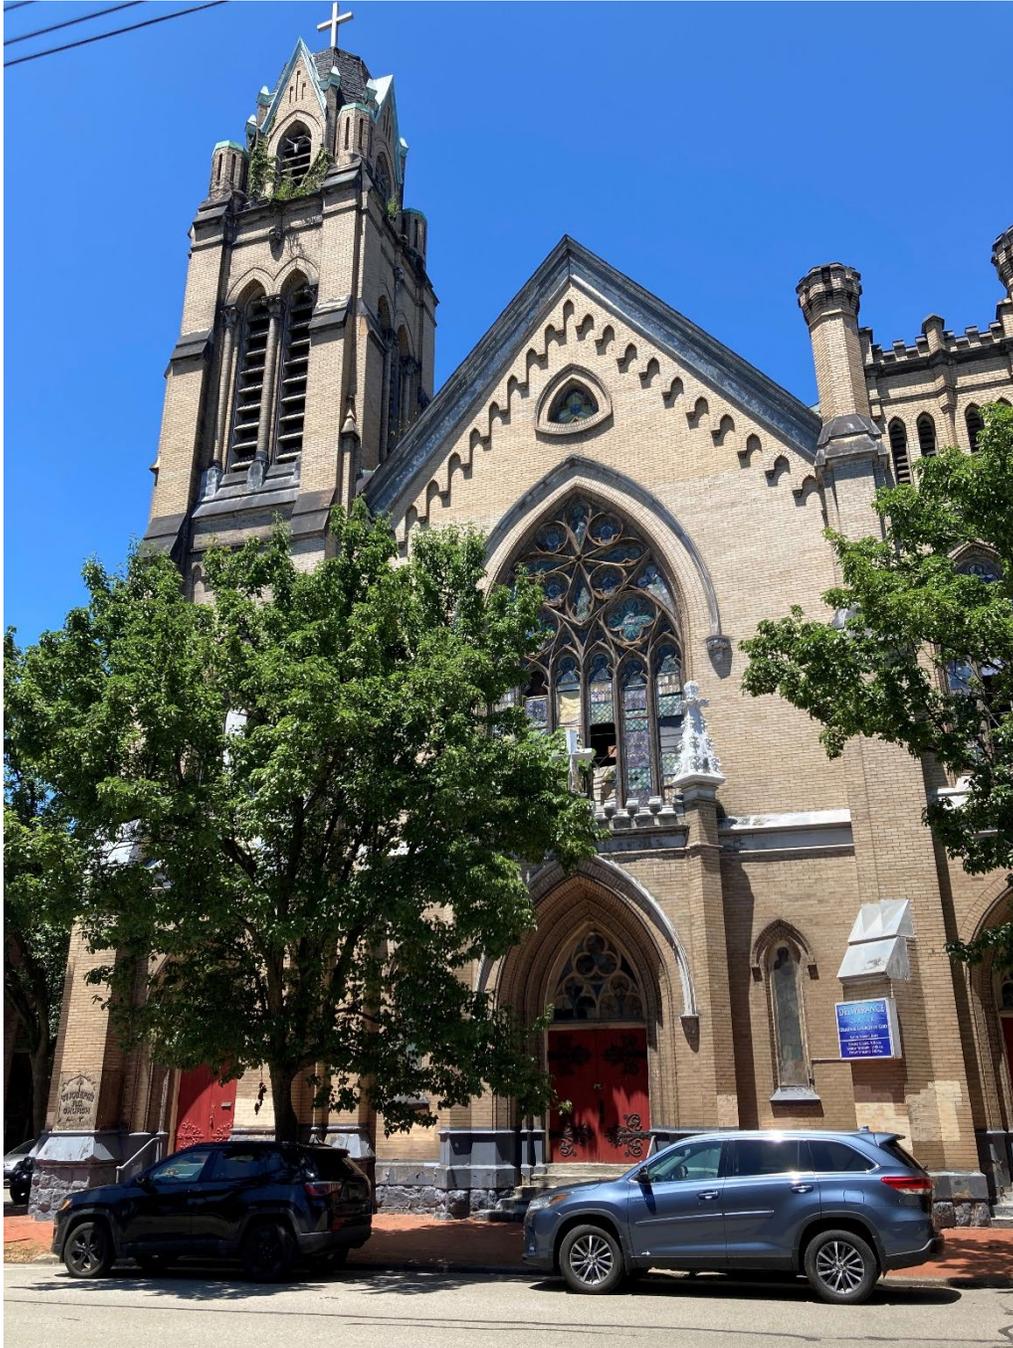
Photo No.1 –Front elevation of the Building. Note broken and missing stained glass and vegetation growing from the bell tower.

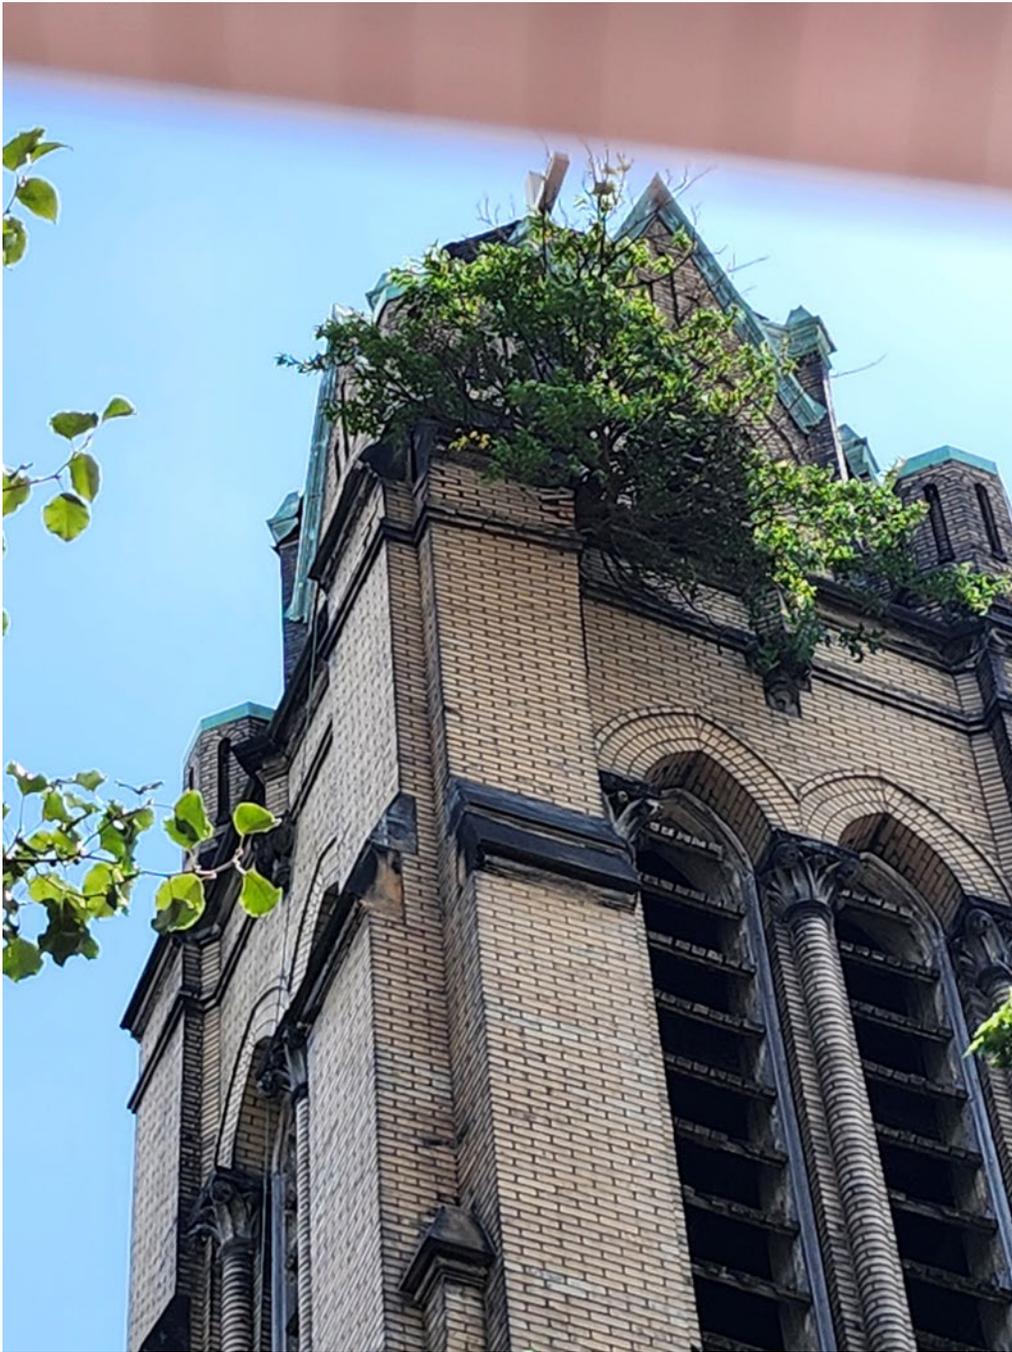
The exterior facade of the building has numerous limestone details at windows, pediments, cornices, faux buttresses and tower elements. Based on visual observations from street level, much of the limestone construction appears to be loose and it is presumed that the connection between the limestone and supporting structure has deteriorated. The exterior wall construction would require a complete restoration if the building were to be rehabilitated and occupied. The required remediation would include, but is not limited to: repair and replacement of all missing and damaged brick masonry; repair and replacement of all damaged and missing limestone façade elements; removal of all interior plaster, repointing of the interior face of the brick masonry and installation of new stud wall construction or furring to help laterally support the brick and allow for the installation of MEP elements, and construction of a fully functioning building envelope including insulation, waterproofing and a thermal break.

There are numerous locations where trees and vegetation are growing from openings and projections in the exterior wall construction. As this vegetation continues to expand, it will lead to further deterioration of the existing structure. In addition, the trees growing out of the building may pose a threat of falling to the sidewalk below, particularly during wind events or under the weight of heavy snowfall.

Photo No.2 –Bell Tower. Note vegetation and loose & damaged masonry.

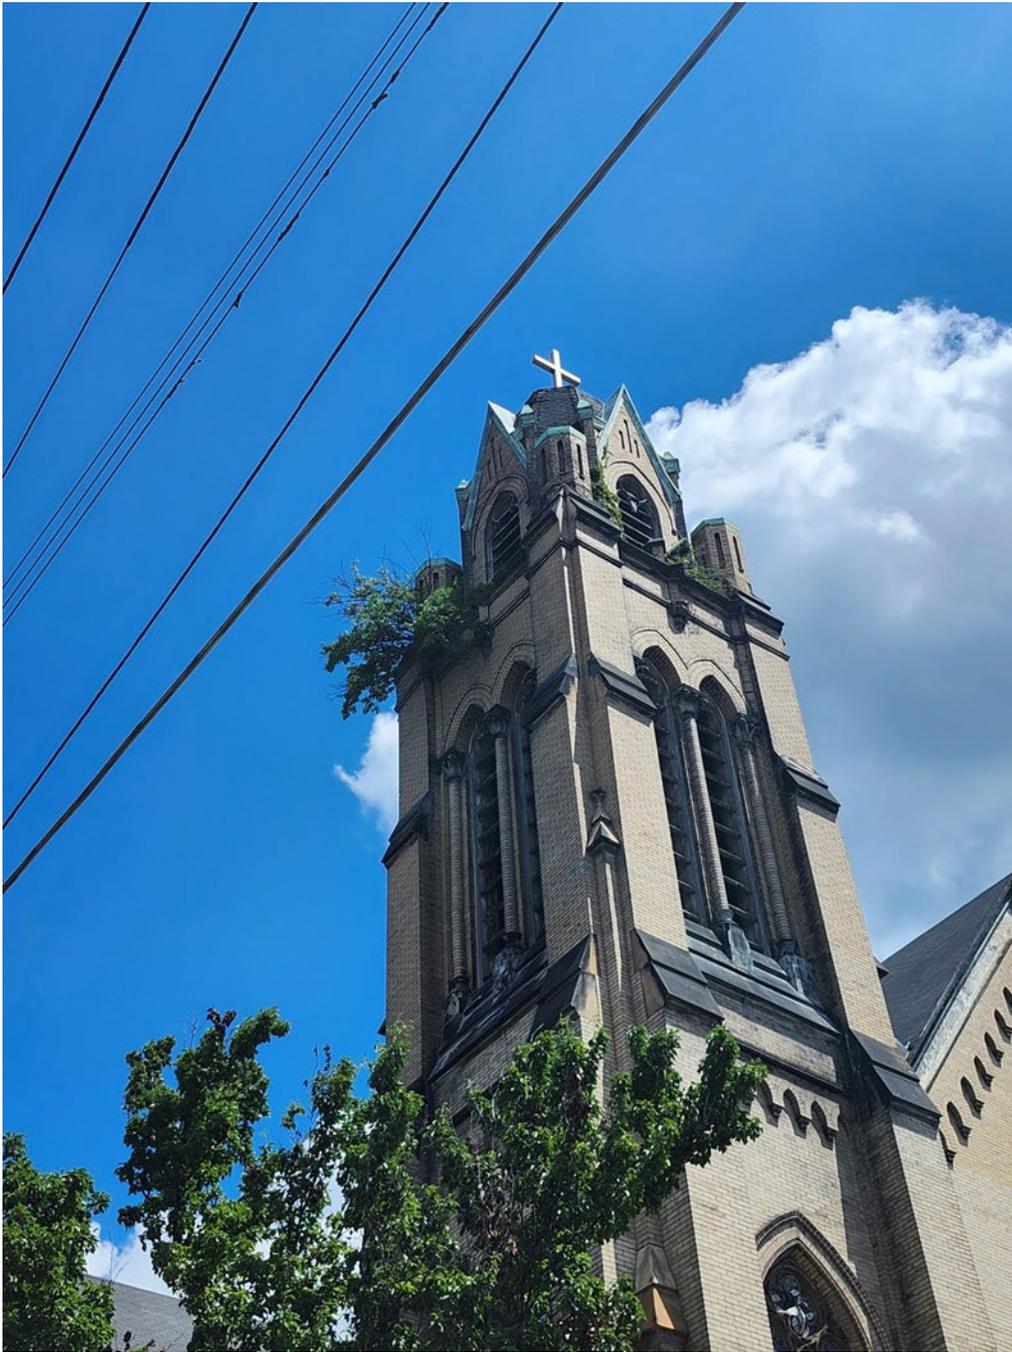
Photo No.3 –Bell Tower. Note vegetation and loose & damaged masonry.

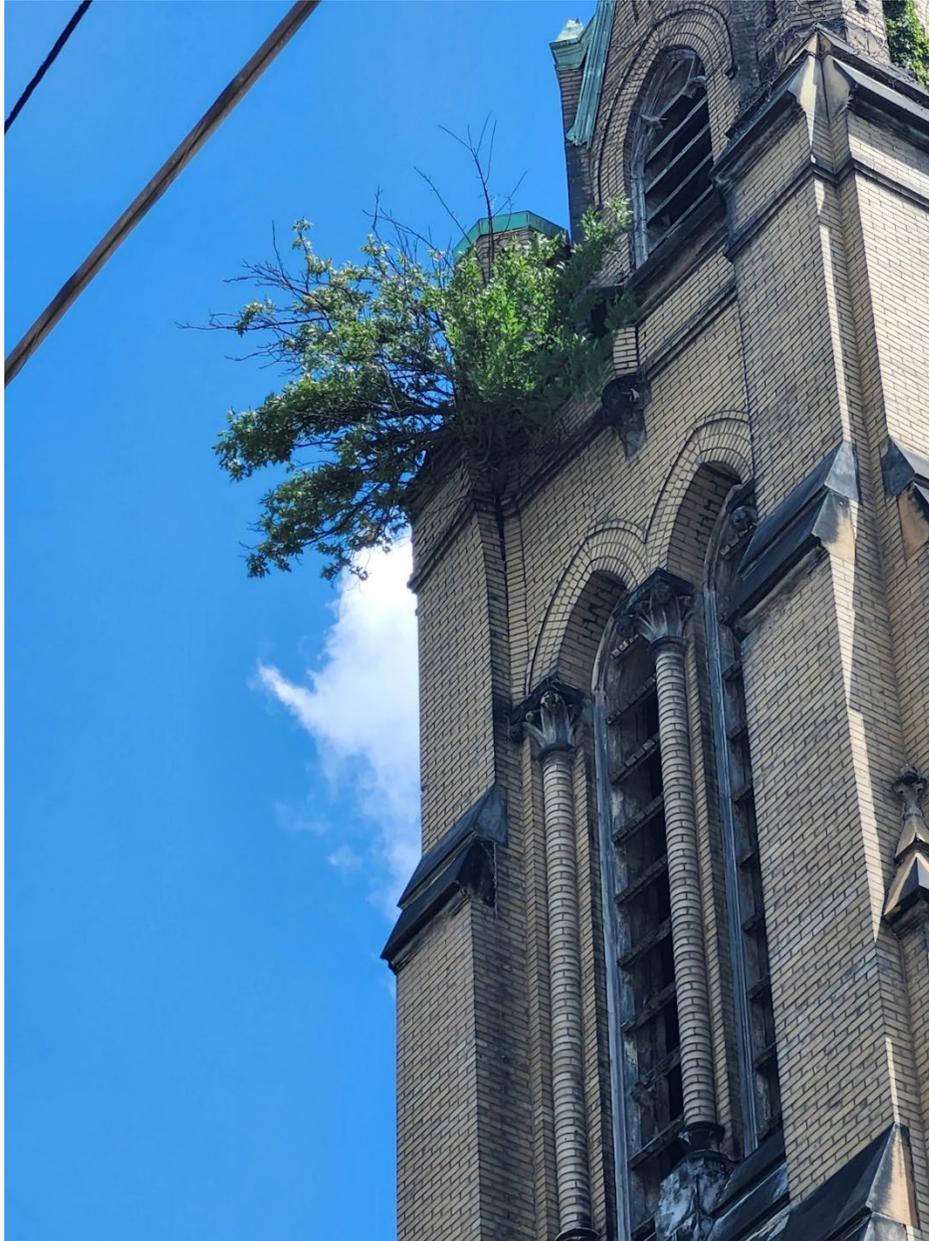
Photo No.4 –Bell Tower. Note vegetation and loose & damaged masonry.

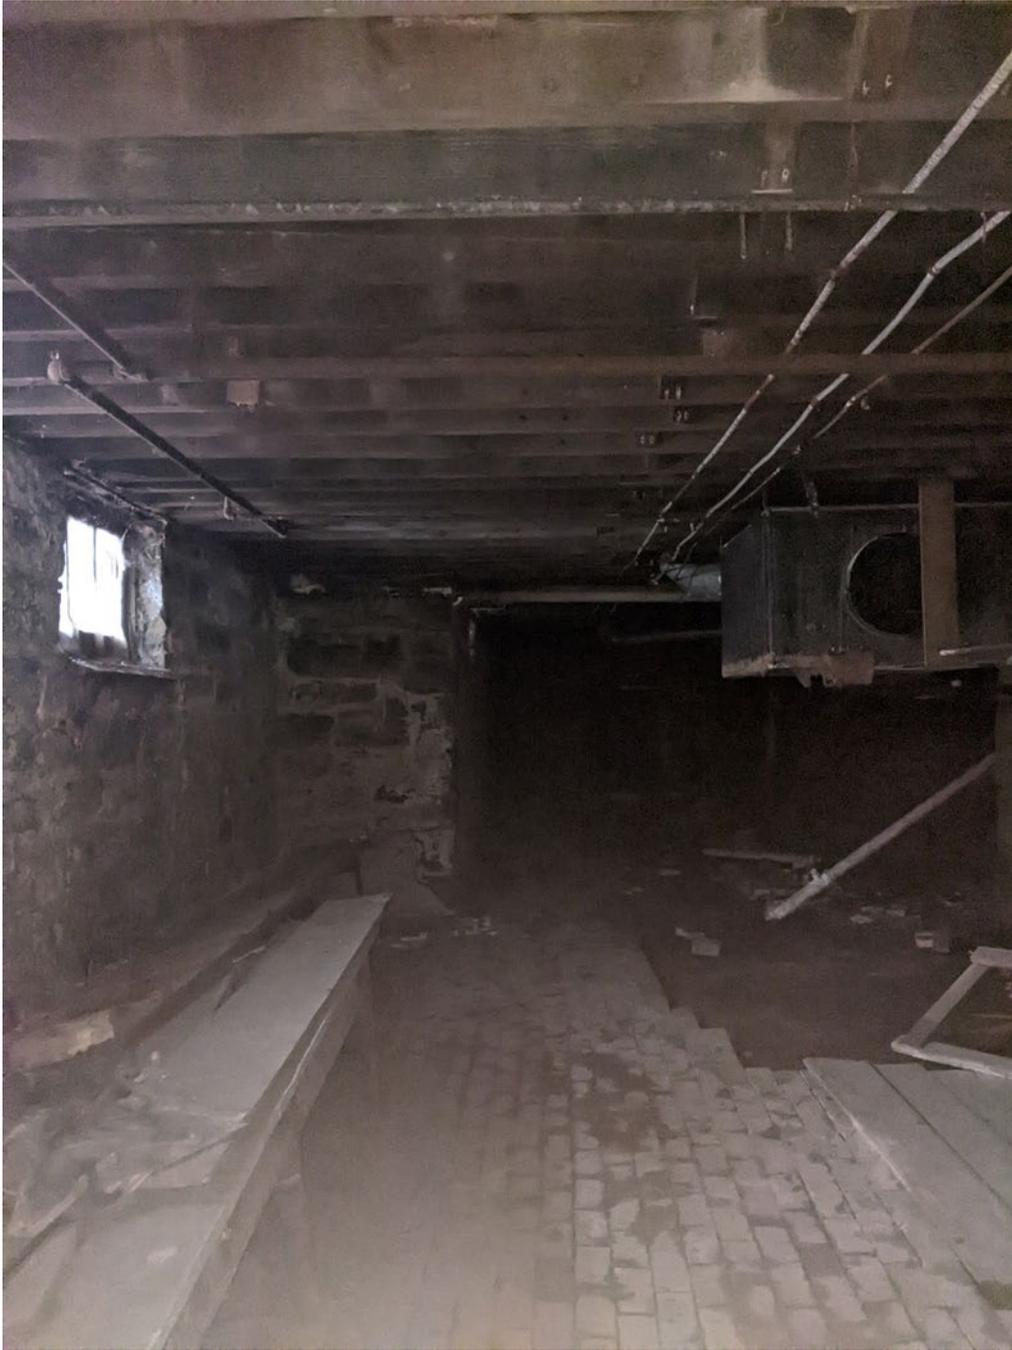
The existing basement/foundation wall construction of the church building consists of stone masonry construction. The basement walls are in fair to poor condition. There are locations where localized failure of the existing stone masonry wall has occurred. In addition, the walls do not appear to have a functioning waterproofing or damp proofing system. The basement space is very damp and appears to experience periodic intrusions of water, likely during heavy rain events. Portions of the basement have a wood block flooring system. However, there are large areas of the basement where the wood block system has been removed exposing the subgrade material. There is no vapor barrier present in the plane of the basement floor which is contributing to the moisture problems in the space.

Photo No.5 –View of stone masonry basement wall and wood block flooring.

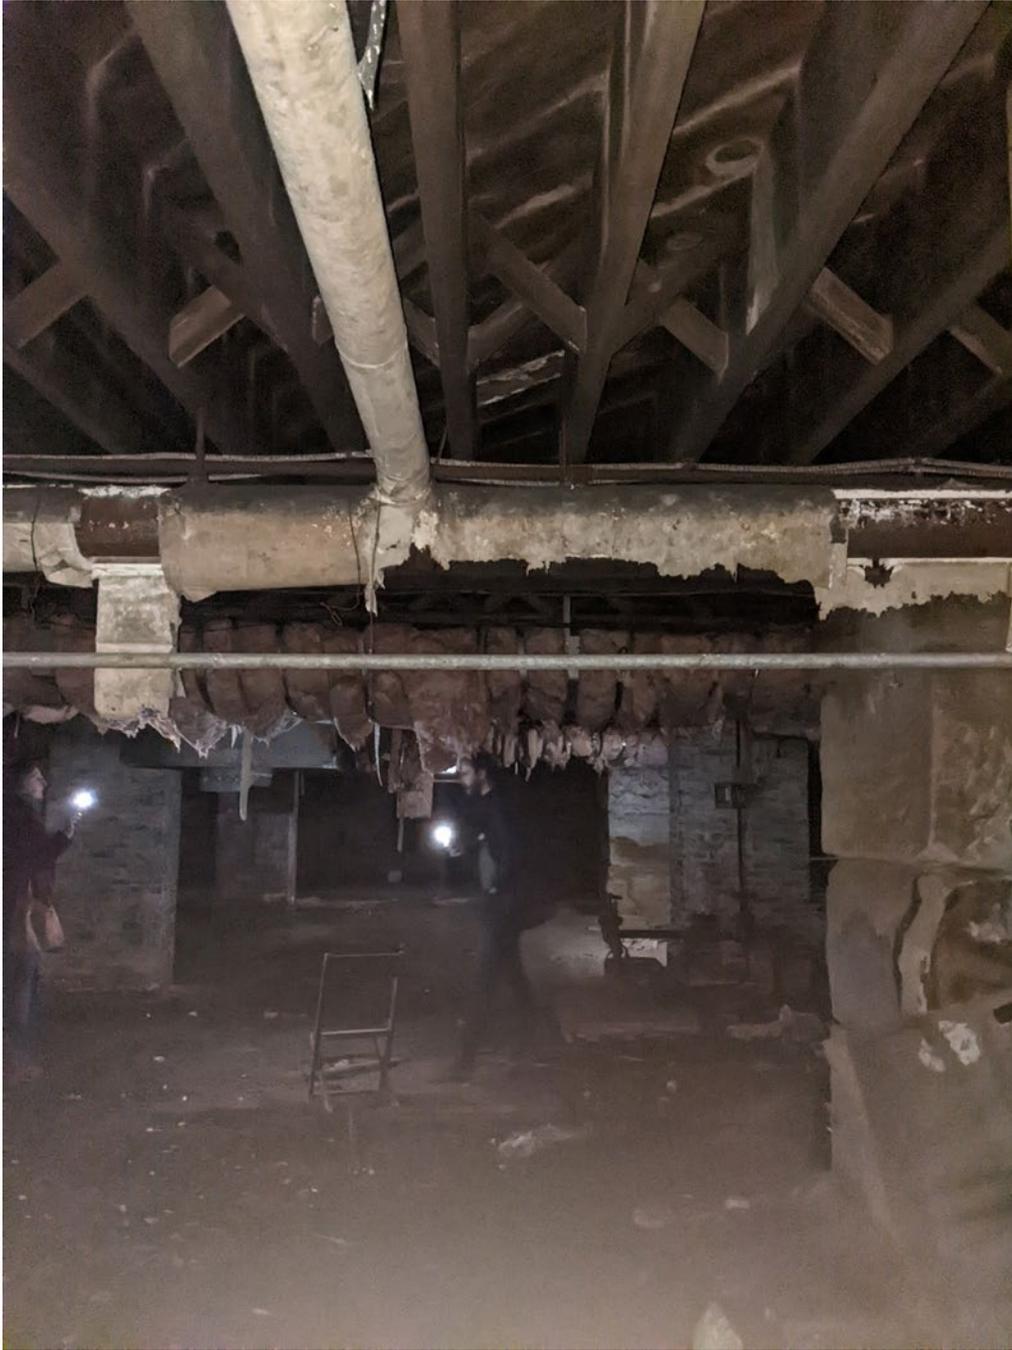
There are stone and brick masonry pilasters visible on the basement space that support the first-floor framing. The existing first-floor construction of the building is exposed and visible from the basement. It appears to typically consist of a series of true 2x wood joists and steel junior beams supporting a concrete slab combined with wood and timber framing supporting wood plank flooring. The first-floor construction appears to be in fair to poor condition. However, it has localized areas of damage where significant water infiltration and/or roof failure has occurred above.

Photo No.6 –View of first floor framing from basement, note stone and brick masonry piers in background and exposed ground floor.

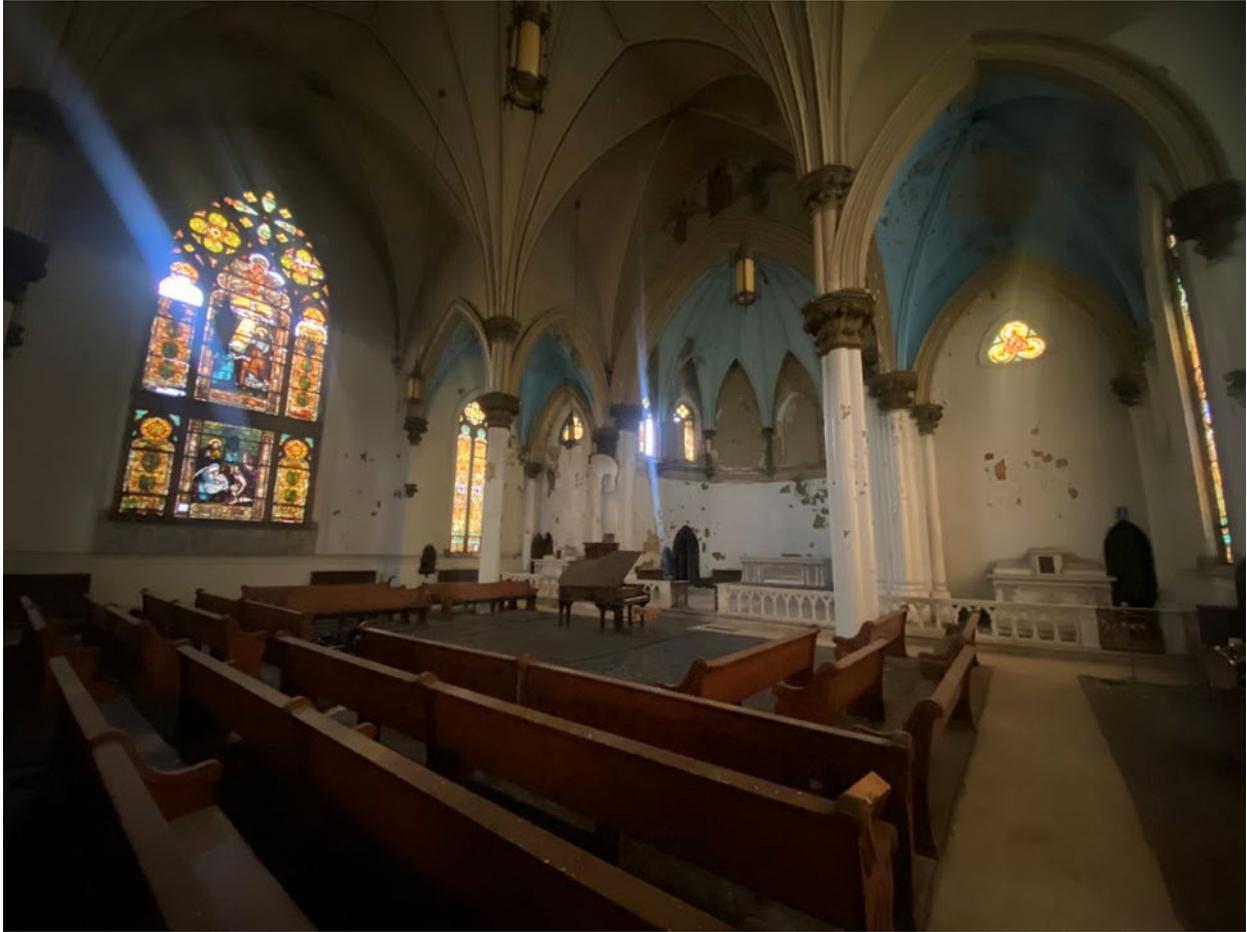
Photo No.7 –View of first floor looking toward the chancel. Note missing stained glass in window, peeling paint and plaster on walls and ceiling.

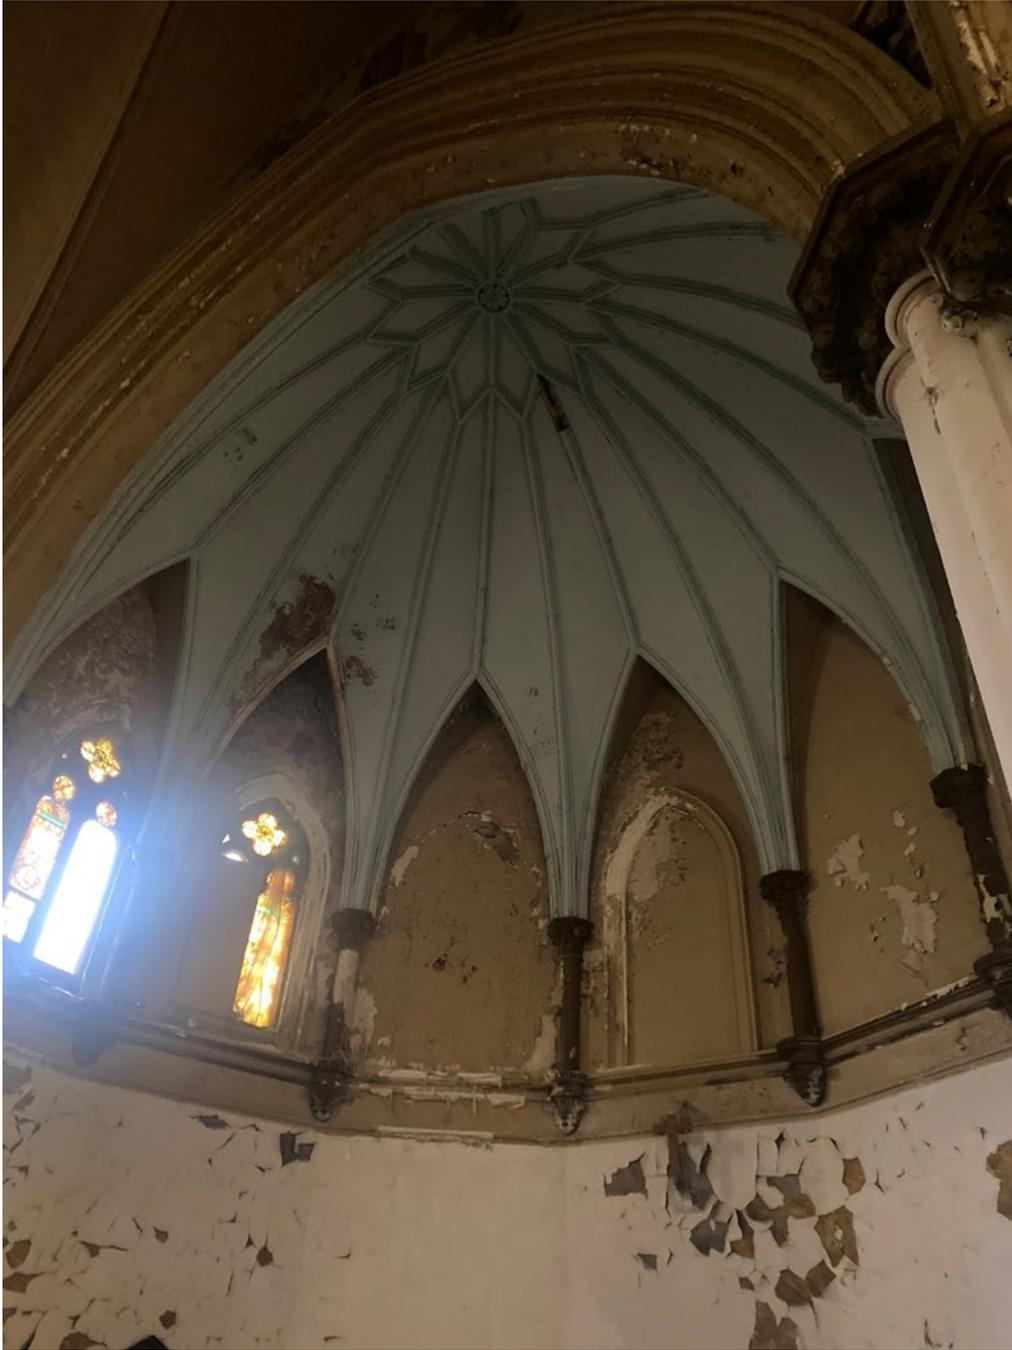
Photo No.8 –View of first floor looking toward the dome above the aspe. Note the peeling paint and plaster and damaged and missing stained glass in the windows.

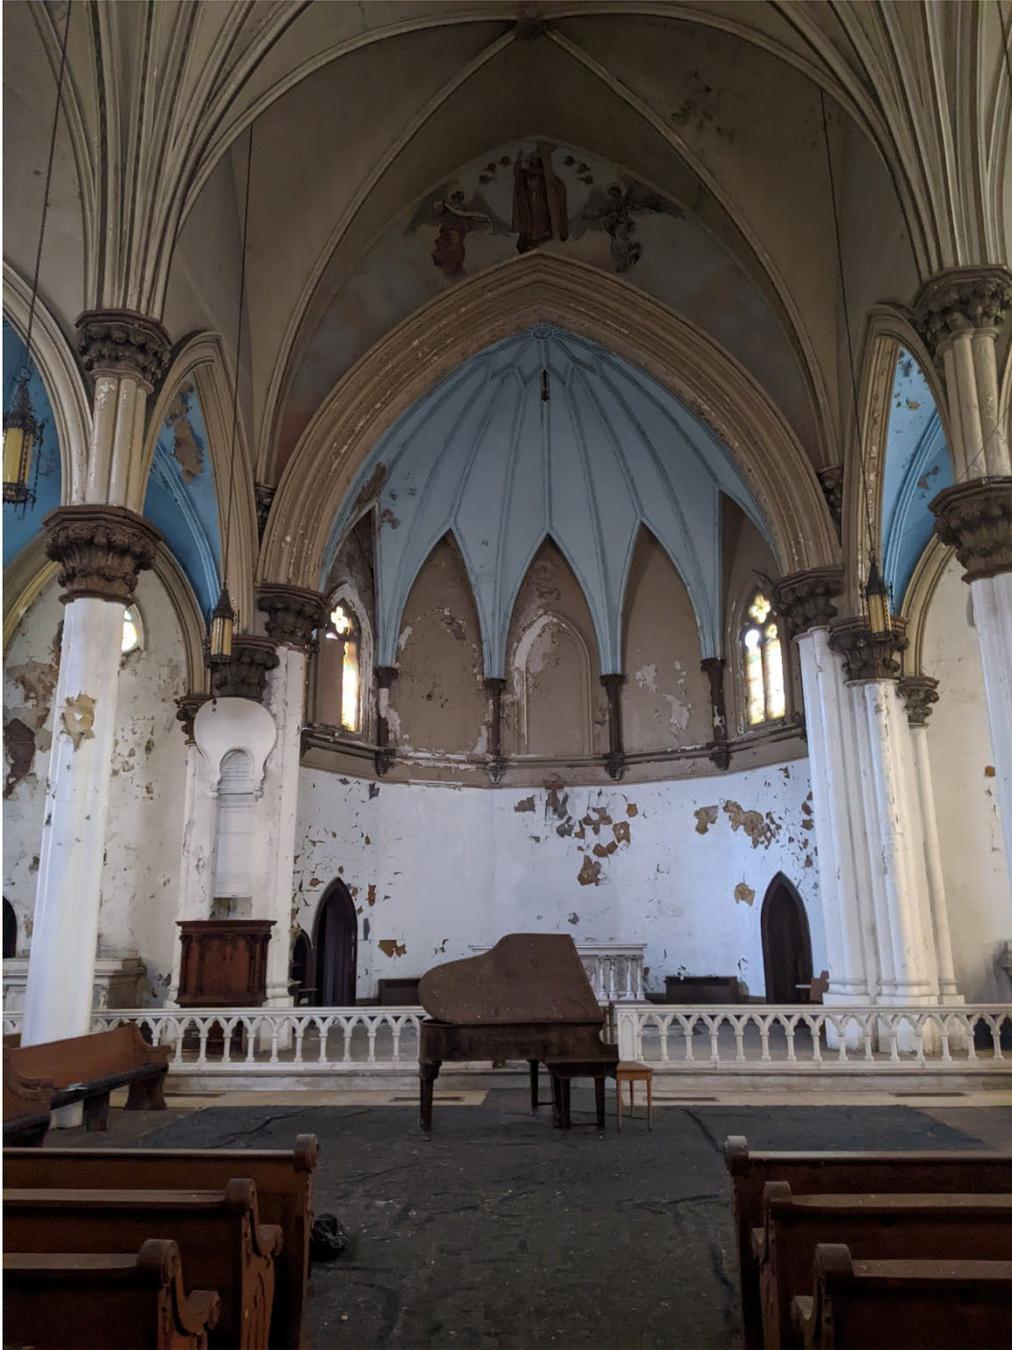
Photo No.9 –View of first floor looking toward the chancel and aspe. Note the peeling paint and plaster and damaged and missing stained glass in the windows.

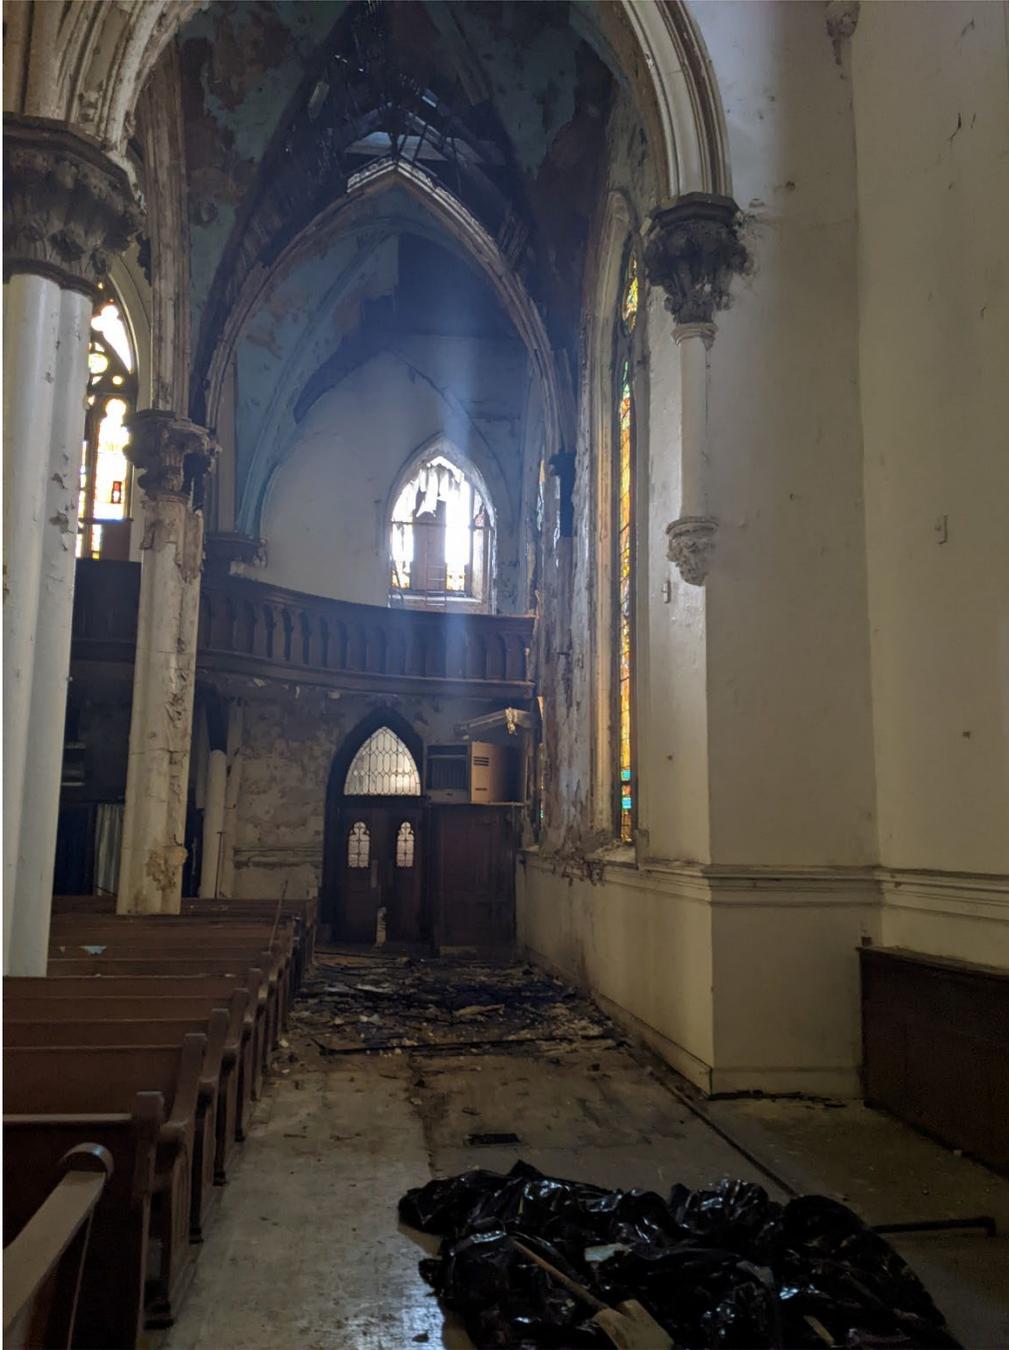
Photo No.10 –View of first floor looking toward the rear of the nave (looking southwest toward Liverpool). Note the failed roof condition and deteriorated condition of the adjacent wall construction and the missing stained glass beyond.

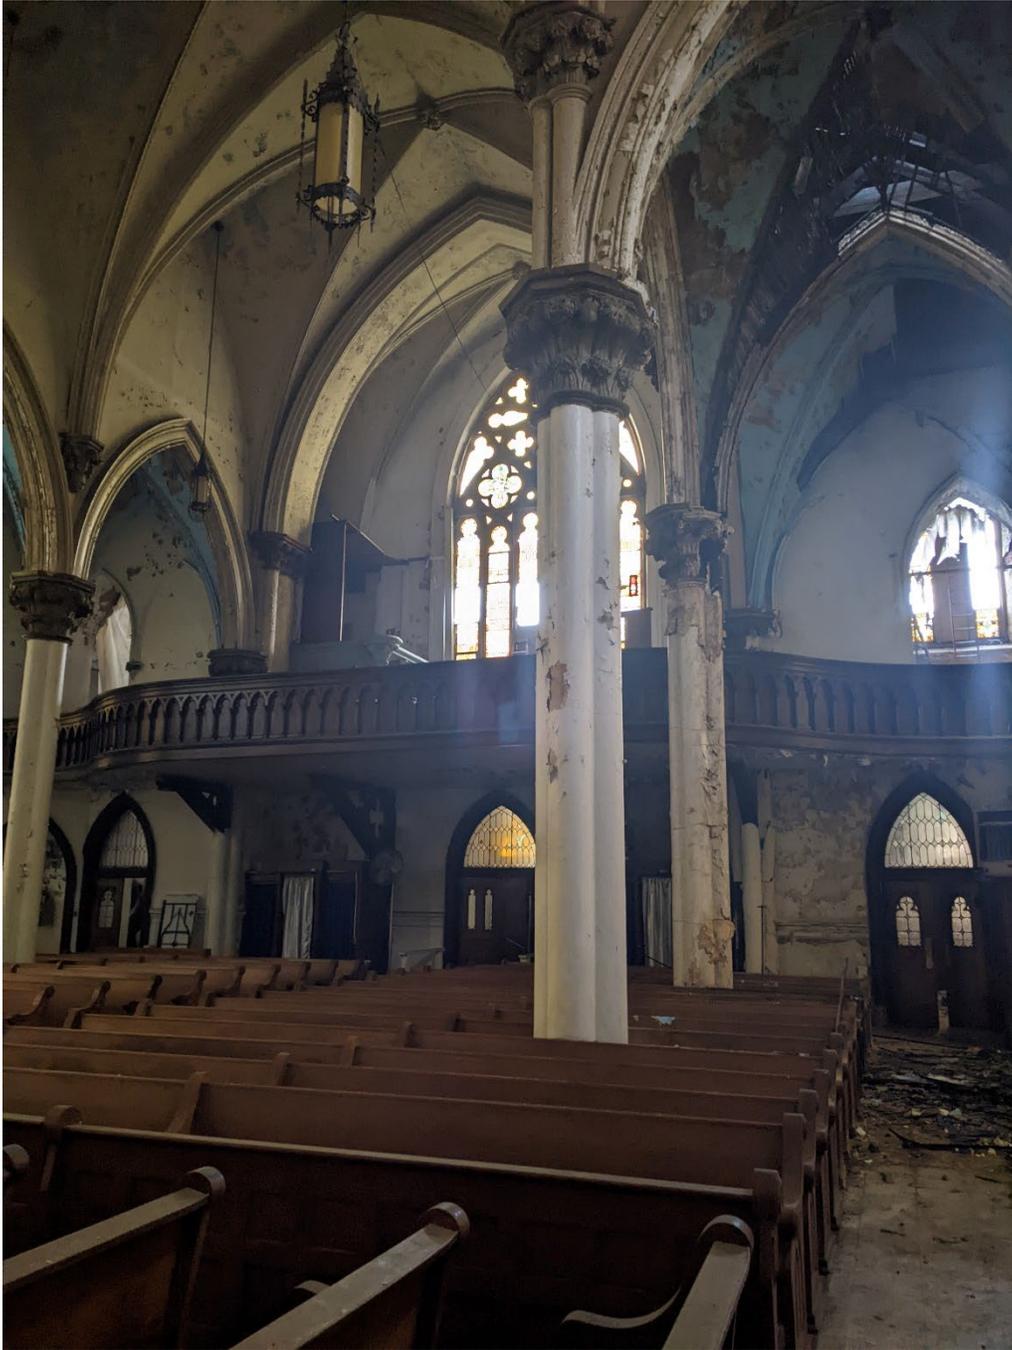
Photo No.11 –View of first floor looking toward the rear of the nave (looking southwest toward Liverpool). Note the failed roof condition and deteriorated condition of the adjacent wall construction and the missing stained glass beyond.

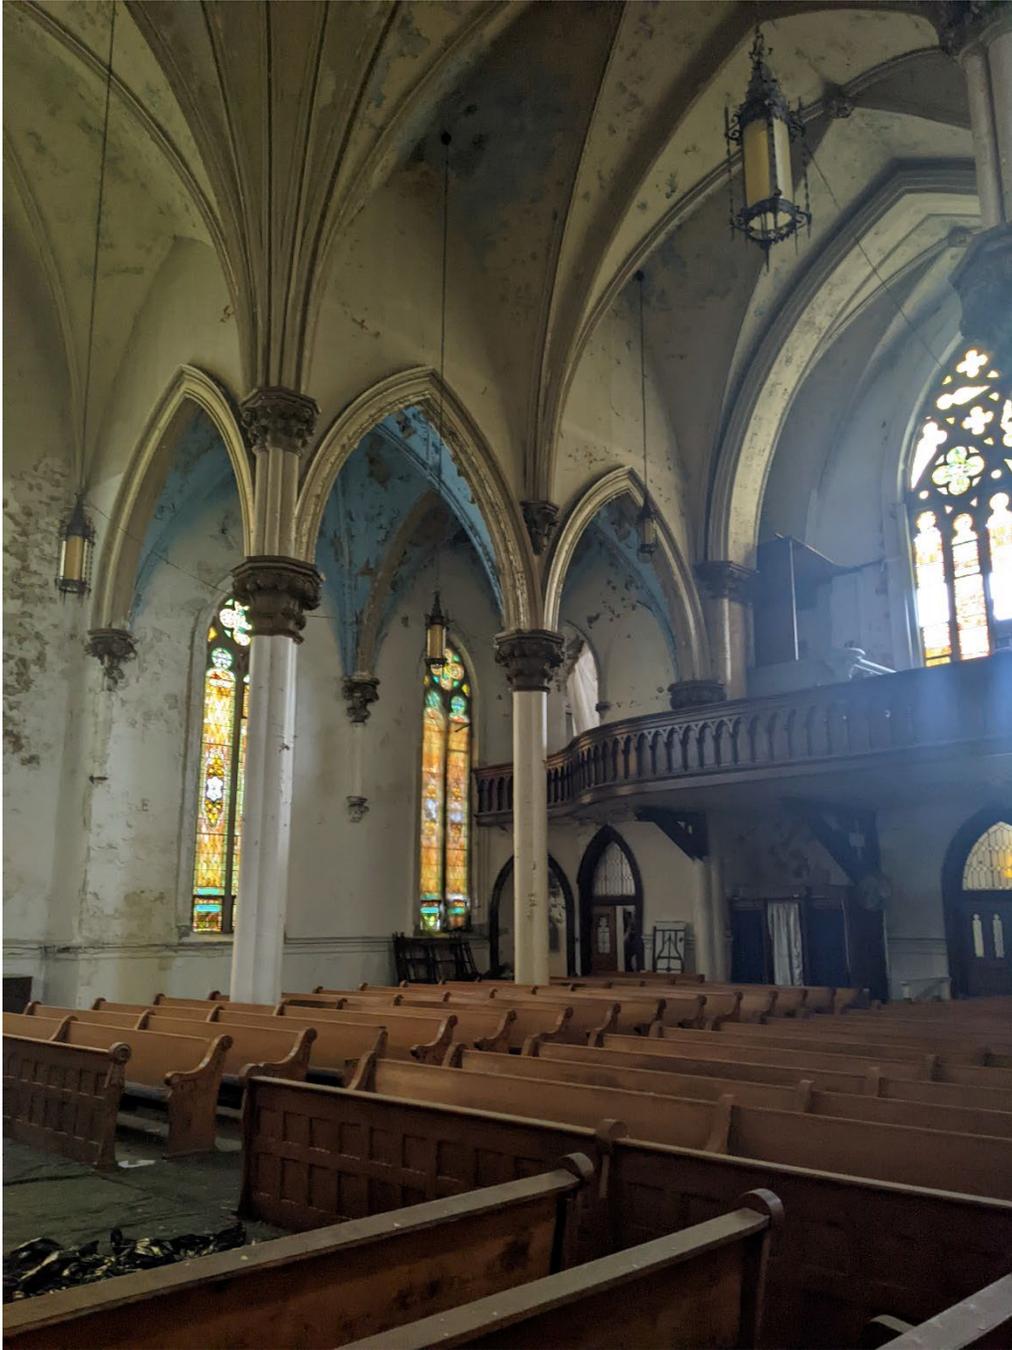
Photo No.12 –View of first floor looking toward the rear of the nave (looking southeast). Note the failed roof condition and deteriorated condition of the adjacent wall construction and the missing stained glass beyond.

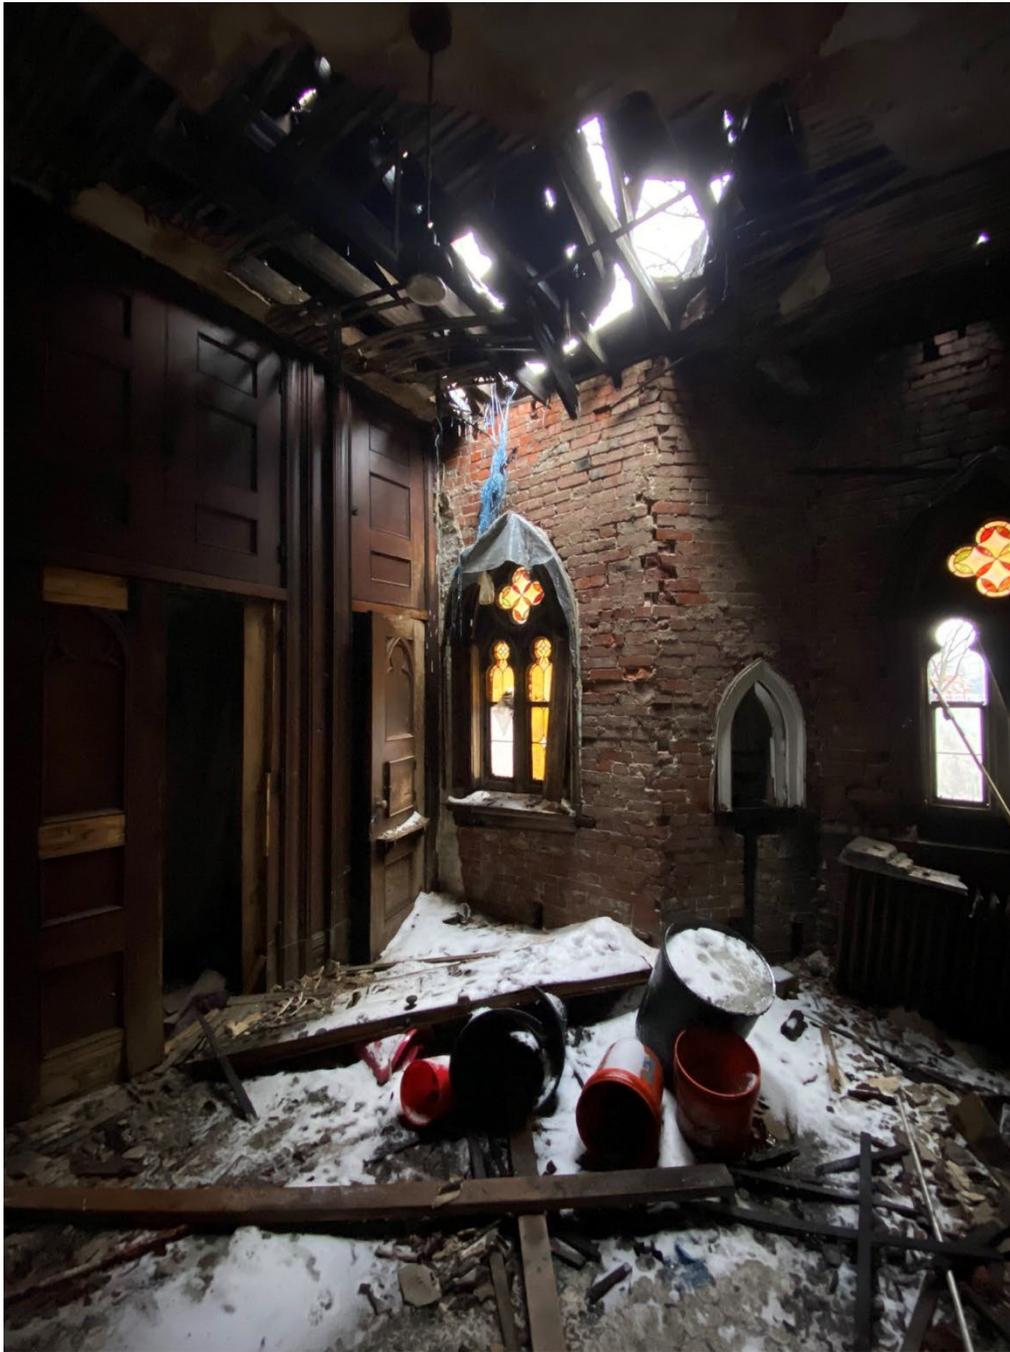
Photo No.13 –Interior view of roof collapse above the chapel at the northwest corner of the building.

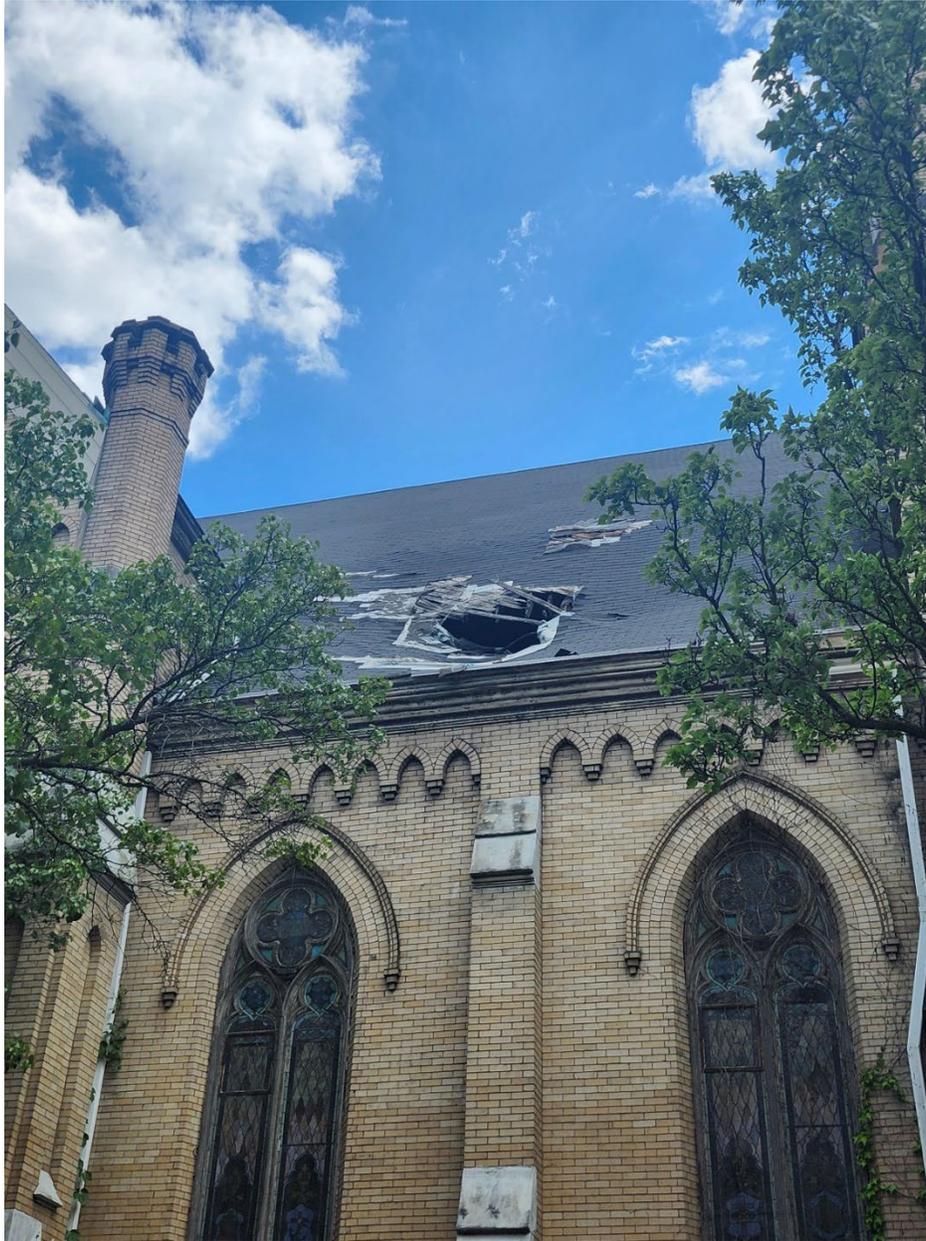
As mentioned above, several areas of the roof have completely failed, including a large area on the west side of the building where the roof structure has collapsed exposing this portion of the sanctuary to open air. In most locations, roof scuppers and downspouts have been clogged with debris and are no longer functioning to efficiently remove water from the roof. In some locations, vegetation is growing out of the gutters and water is left to drain down the outside face of the masonry in sheets. The failure of the roof drainage system is contributing to the deterioration of the exterior wall construction, the basement wall construction and the roof construction. As noted above, a significant amount of vegetation is growing from openings in the exterior wall construction. Vegetation is also growing from most of the gutters that remain on the building. This is an indication that the gutters are completely full of debris and not functioning to direct water to the remaining downspouts.

Photo No.14 –Exterior view of roof failure above the nave on the west side of the building (along Decatur).

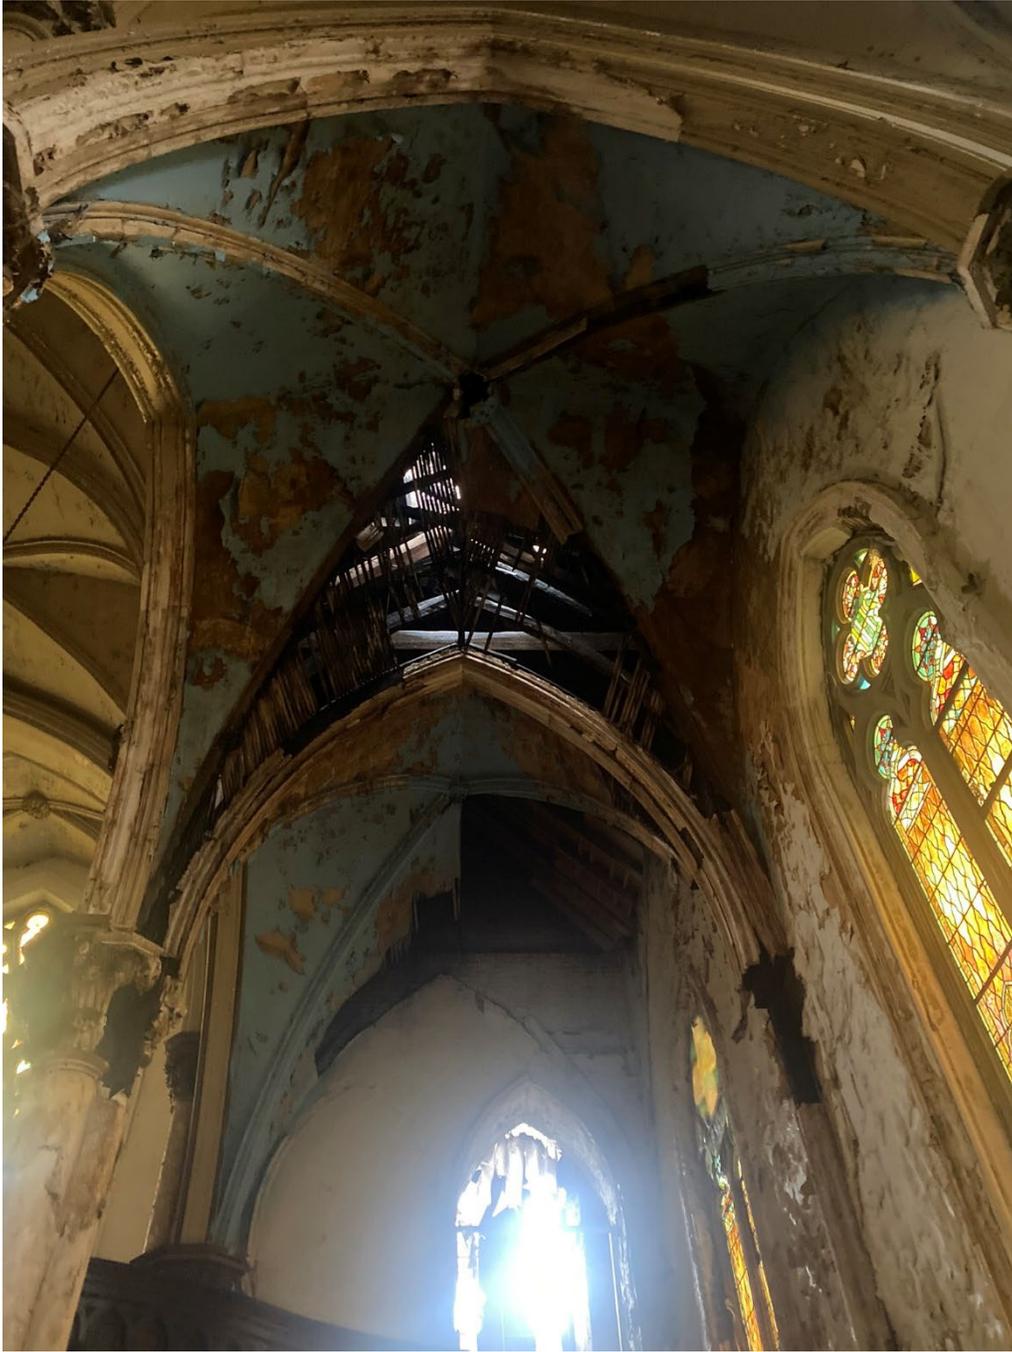
Photo No.15 –Interior view of roof failure above the nave on the west side of the building (along Decatur).
