2018 5th Ave: Demolition of Addition & Garage

Keebler Properties

Structural Problems with Addition & Demolition Justification

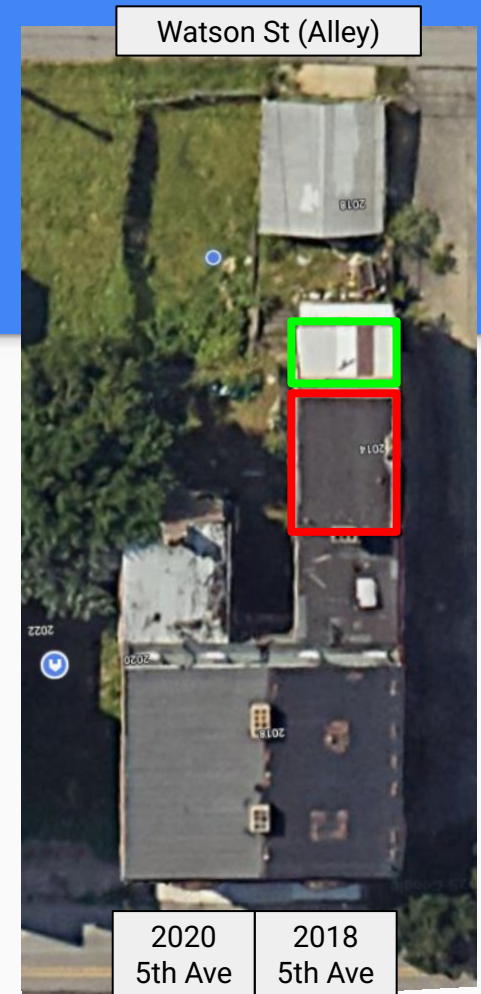
- 2 additions have been added to the house over the years:
 - A 2-story brick addition with stone foundation - Red Outline.
 - A smaller, wood-framed, 2-story structure - Green Outline.
- Lack of maintenance over the years, plus a fire started by squatters, caused the additions' foundations, masonry walls and floor structures to fail.
- Restoration was considered, but due to its complexity, many masonry contractors passed on bidding on the project and those that did provided very high prices.
- If the masonry restoration was taken on, the additional cost of required interior renovations increased the overall project budget to the point that it was no longer financially viable.

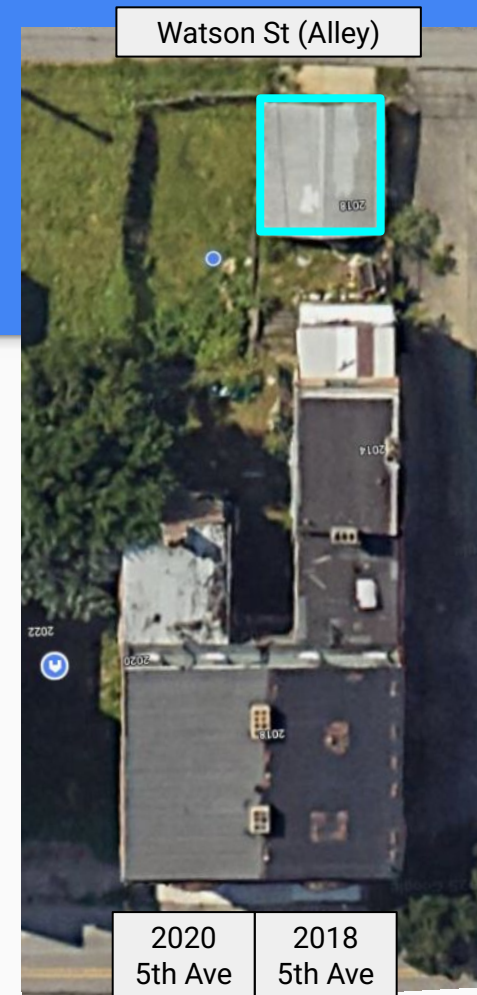
- The current concrete block garage (outlined in blue) does not span the entire width of property and is ~17' wide internally.
- Due to the limited width, only 1 car can be accommodated.
- Interior load-bearing wall was removed
- The roof, roof structure, siding and gutters are failing
- The concrete pad inside the garage and sewer lateral below it are beyond repair and need to be entirely replaced.

- **Wood-Framed & Masonry Additions:**
 - Demolish the two additions, leaving parts of the foundation walls to contain permeable pea-gravel patios (gold highlights) and access stairways for tenant use (yellow highlights).
- **Garage:**
 - Demolish the concrete block garage structure, leaving the lower courses to contain a 2-car, permeable parking pad (light blue highlighted area).
- **Original House Structure:**
 - Renovate the original masonry structure into two units: a one-bedroom on the first floor and a 2-bedroom on the second and third floors
