1406 Sheffield Street

Demolition and new construction

HISTORIC REVIEW BOARD PRESENTATION

1406 SHEFFIELD STREET | MANCHESTER DISTRICT

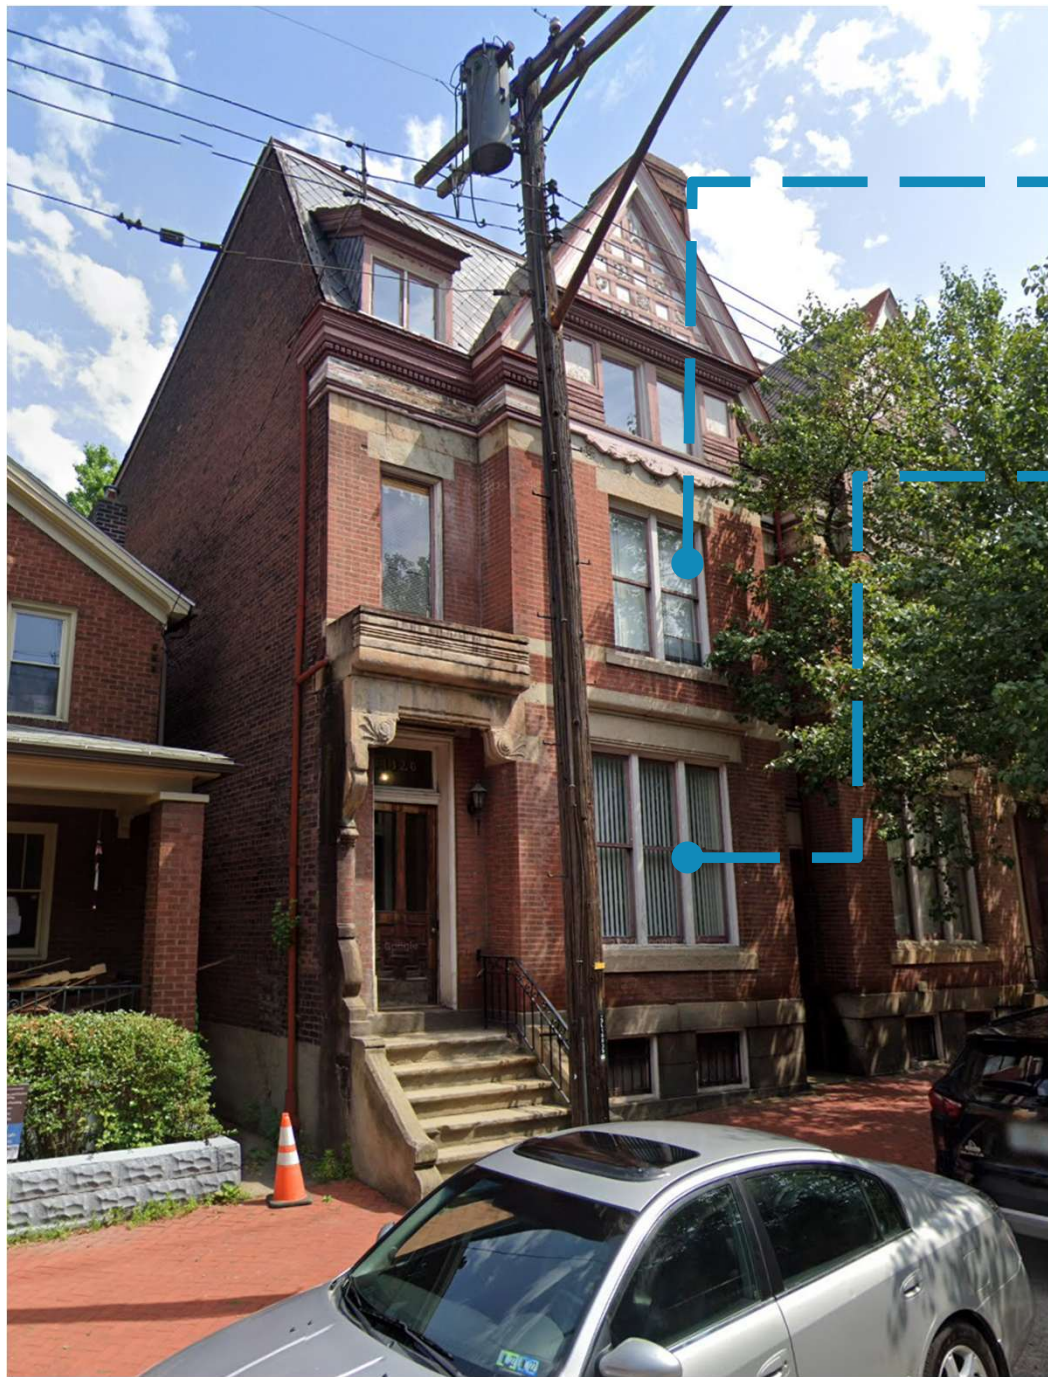
TWO-STORY BRICK ROWHOUSE

MANSARD THIRD-STORY ROOF

CONCRETE ENTRY STEPS W/
BLACK METAL RAIL

RED BRICK STREETFRONT FACADE
DOUBLE HUNG WINDOWS
TRANSOM WINDOWS
SOLID WOOD ENTRY DOOR
TRIPLE GANG WINDOW
THREE-STORY BRICK ROWHOUSE

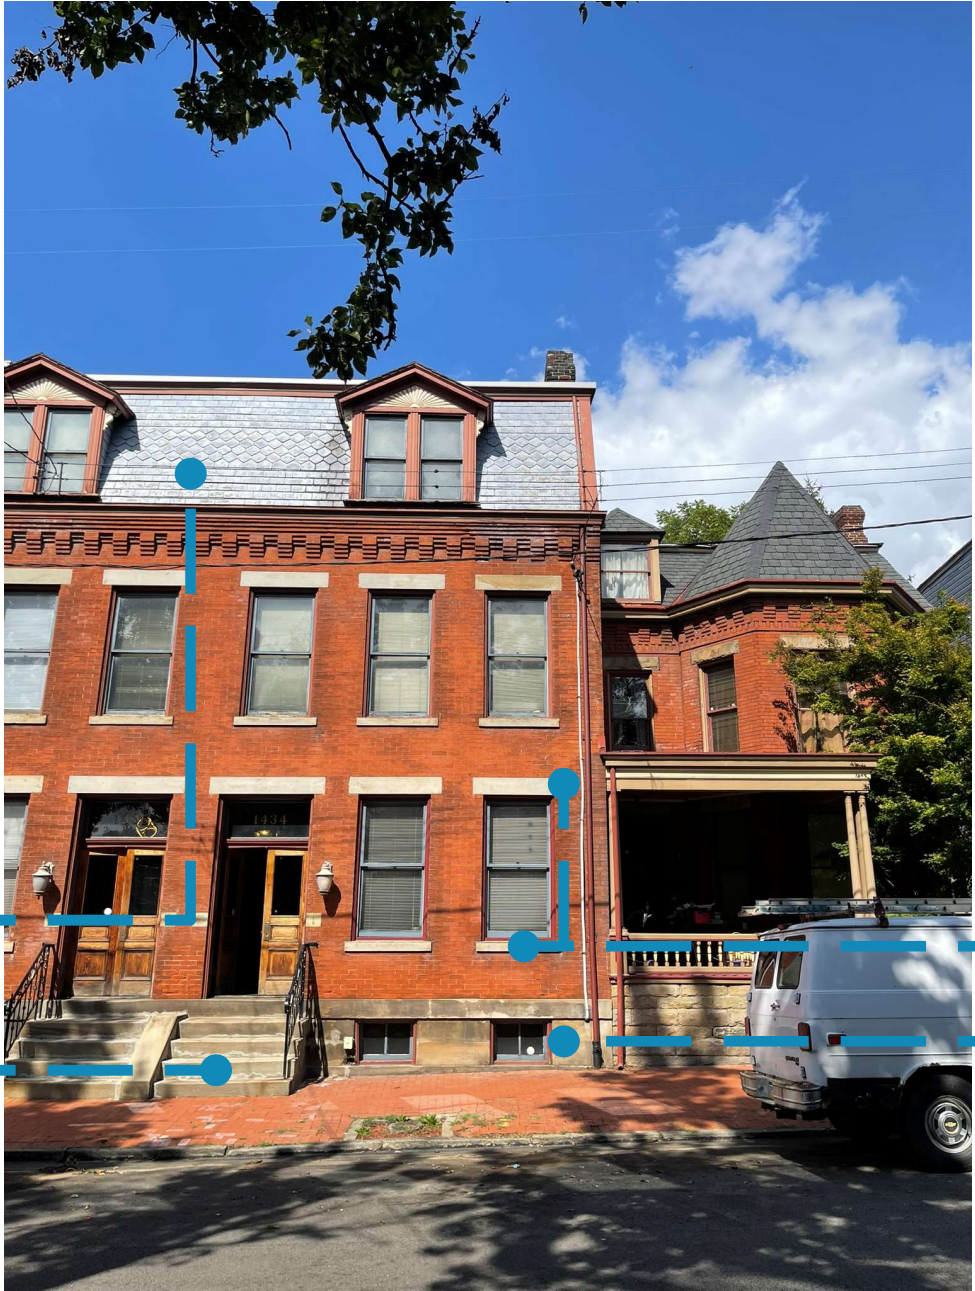
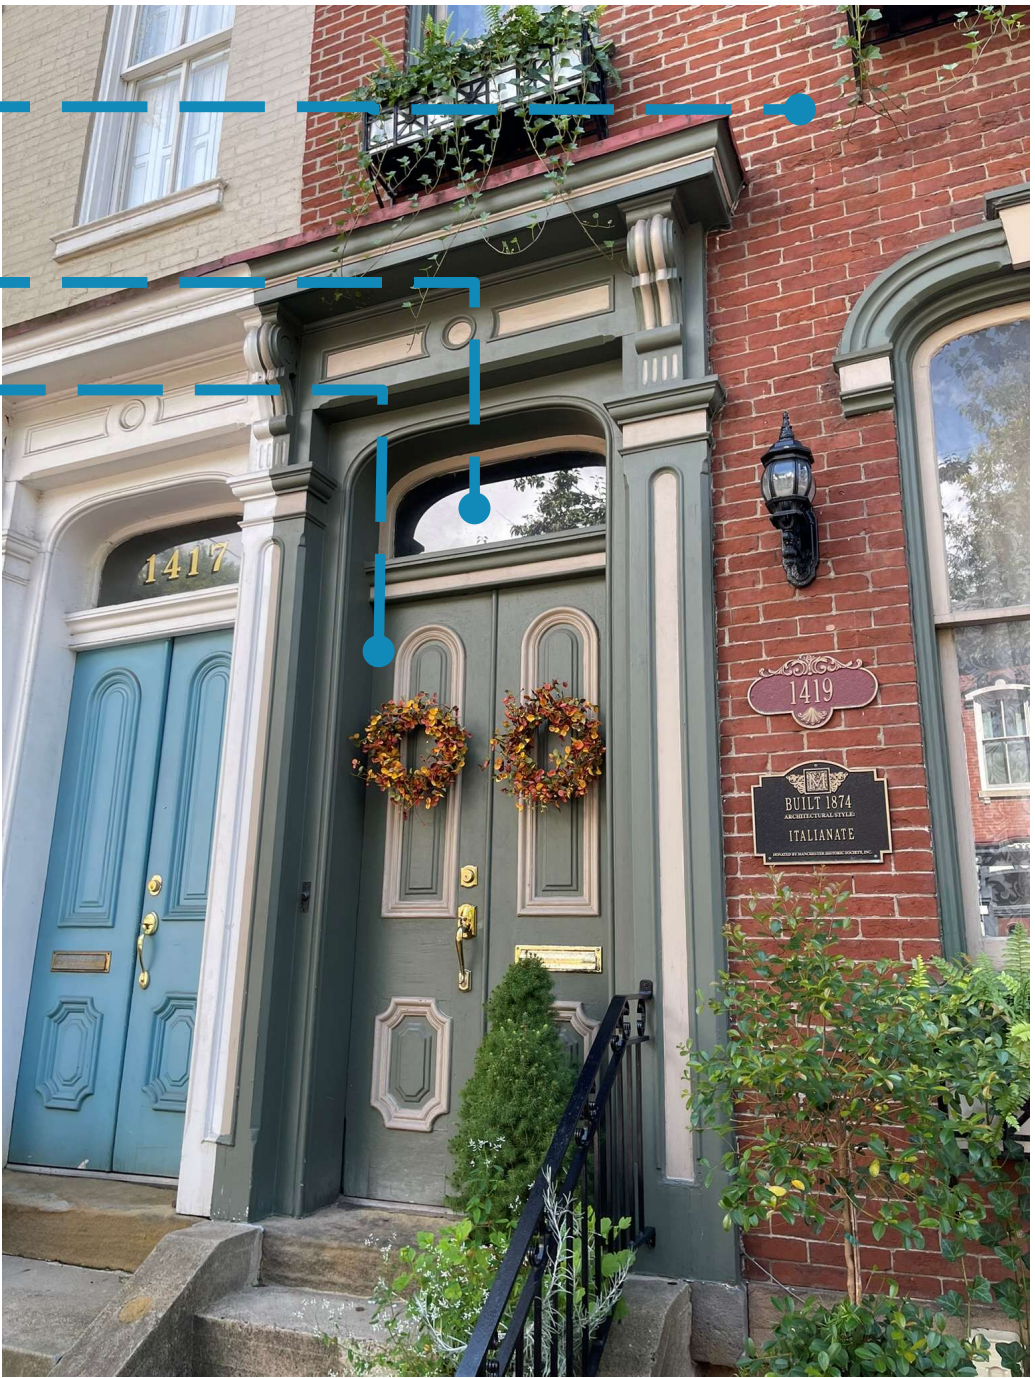
WOOD ENTRY DOOR AND SURROUND

LIMESTONE HEADERS AND SILLS

LIMESTONE BASE COURSE

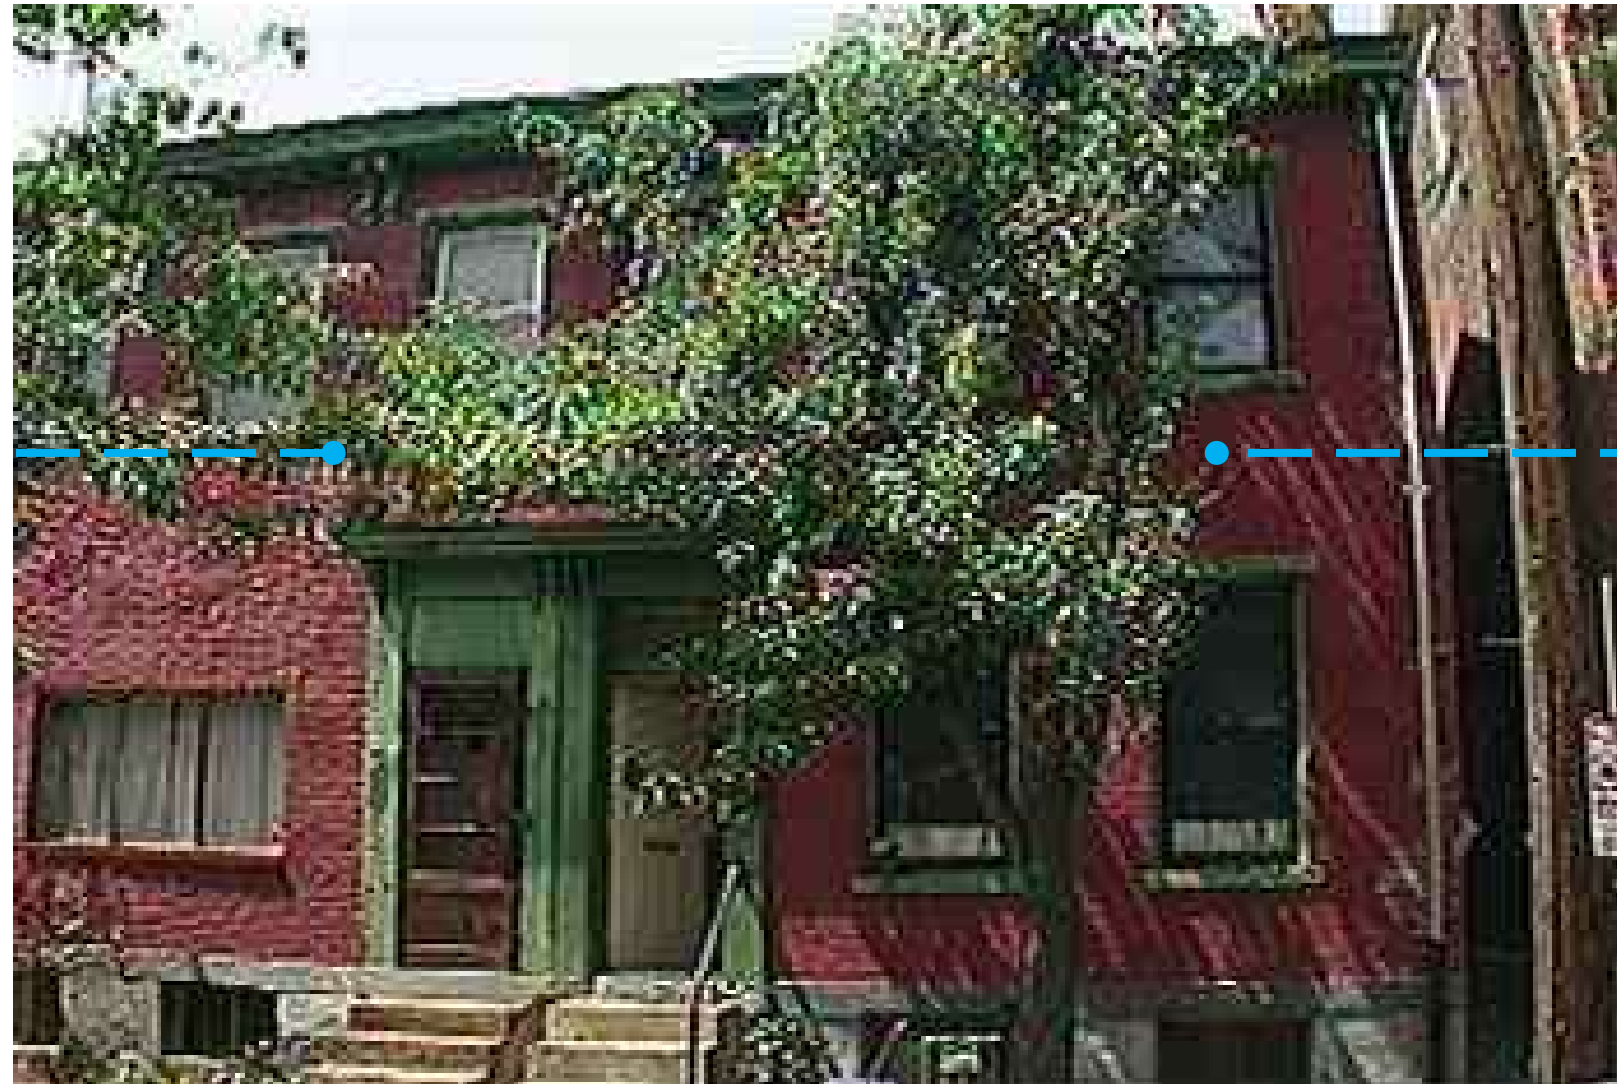
1406 Sheffield Street

COURTESY OF ALLEGHENY COUNTY REAL ESTATE PORTAL. CIRCA 2008.

The neighboring attached structure has been demolished since this photograph.

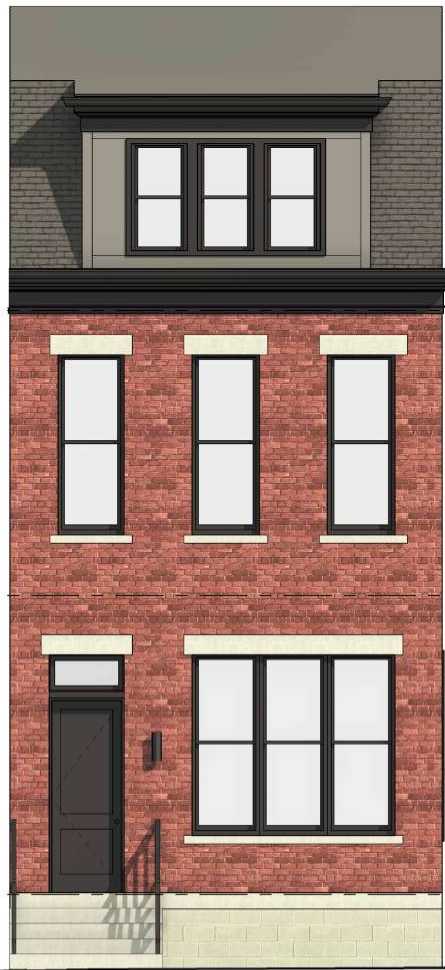
4 SOUTH (STREETFRONT) ELEVATION
1/4" = 1'-0"

THIRD FLOOR T/ SUBFL
124' - 3 1/2"

SECOND FLOOR T/ SUBFL
112' - 4 3/4"

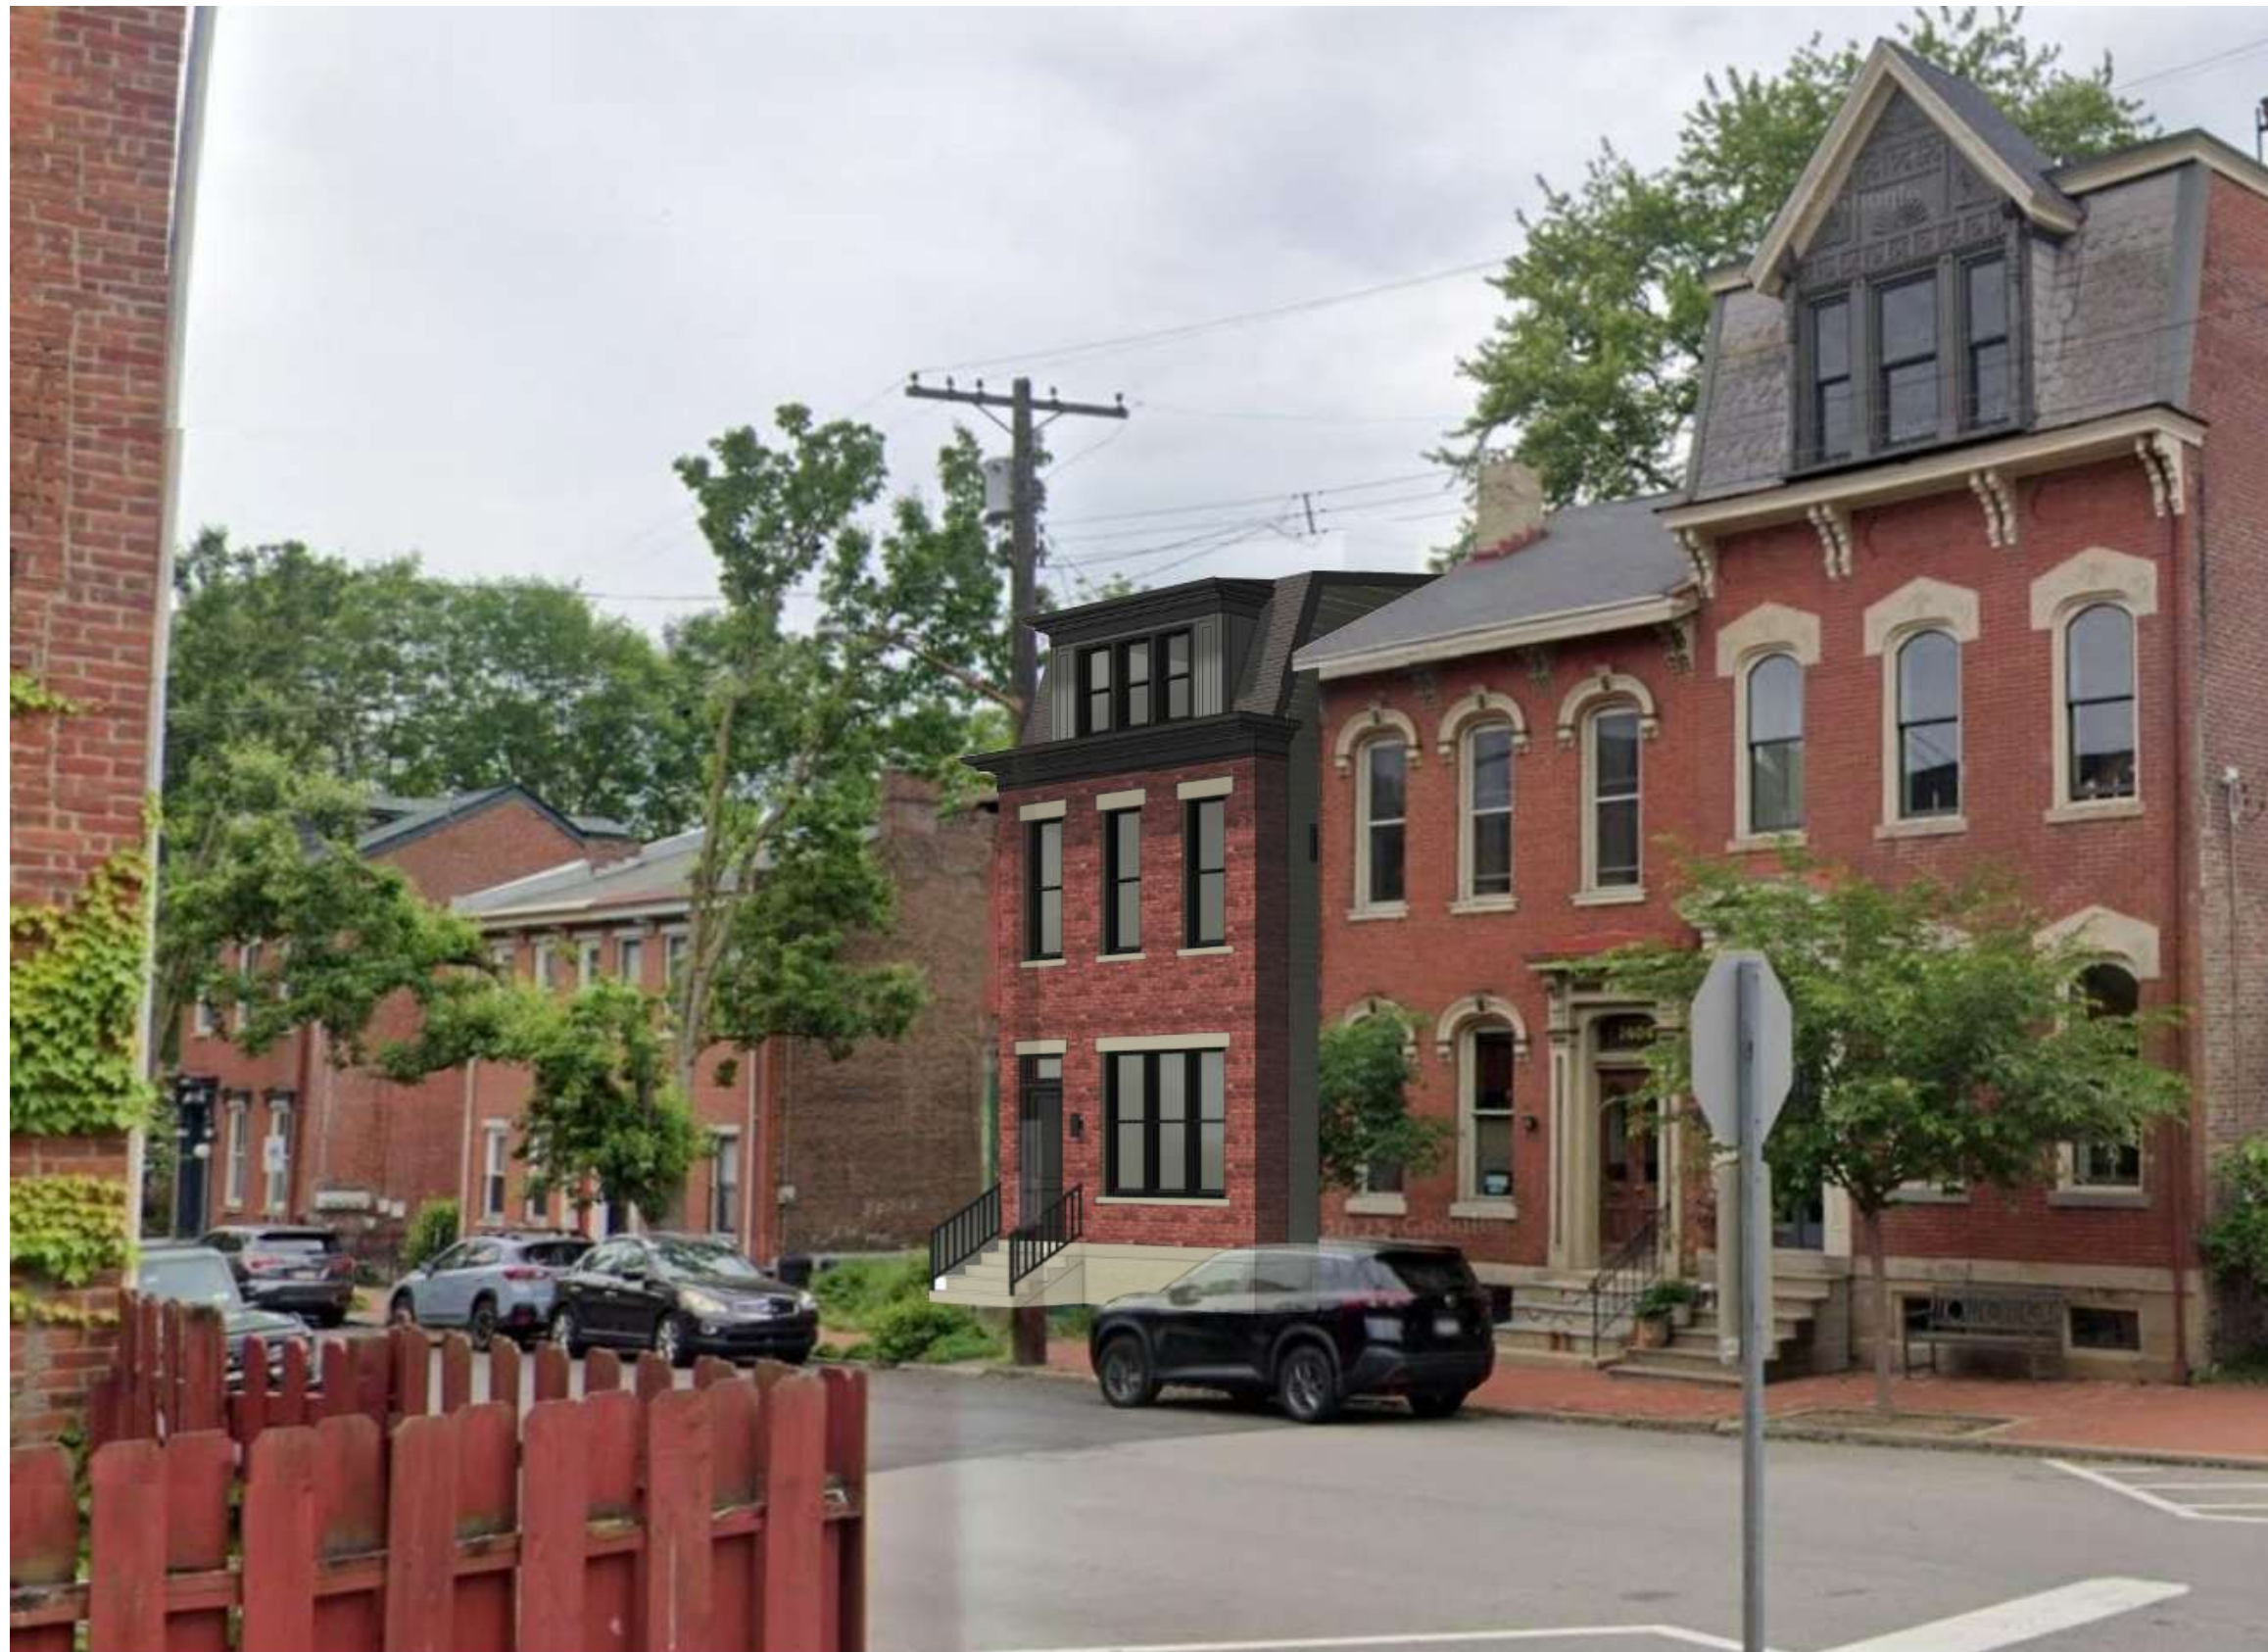
Proposed Structure Architectural Features

1. Flat, red brick front façade w/ punched openings
2. Third-story mansard roof with dormer
3. Limestone headers and sills
4. Double hung windows with vertical proportions
5. Solid wood entry door with transom
6. Concrete entry stairs with metal railing
7. Alignment of belt course of first floor w/ neighboring structure
8. Limestone base course
9. Proportions that align with street context

The most prominent features of the Italianate style are flat facades, vertical proportions, and masonry detailing. Other elements include symmetrical rhythm and low-pitched roofline.

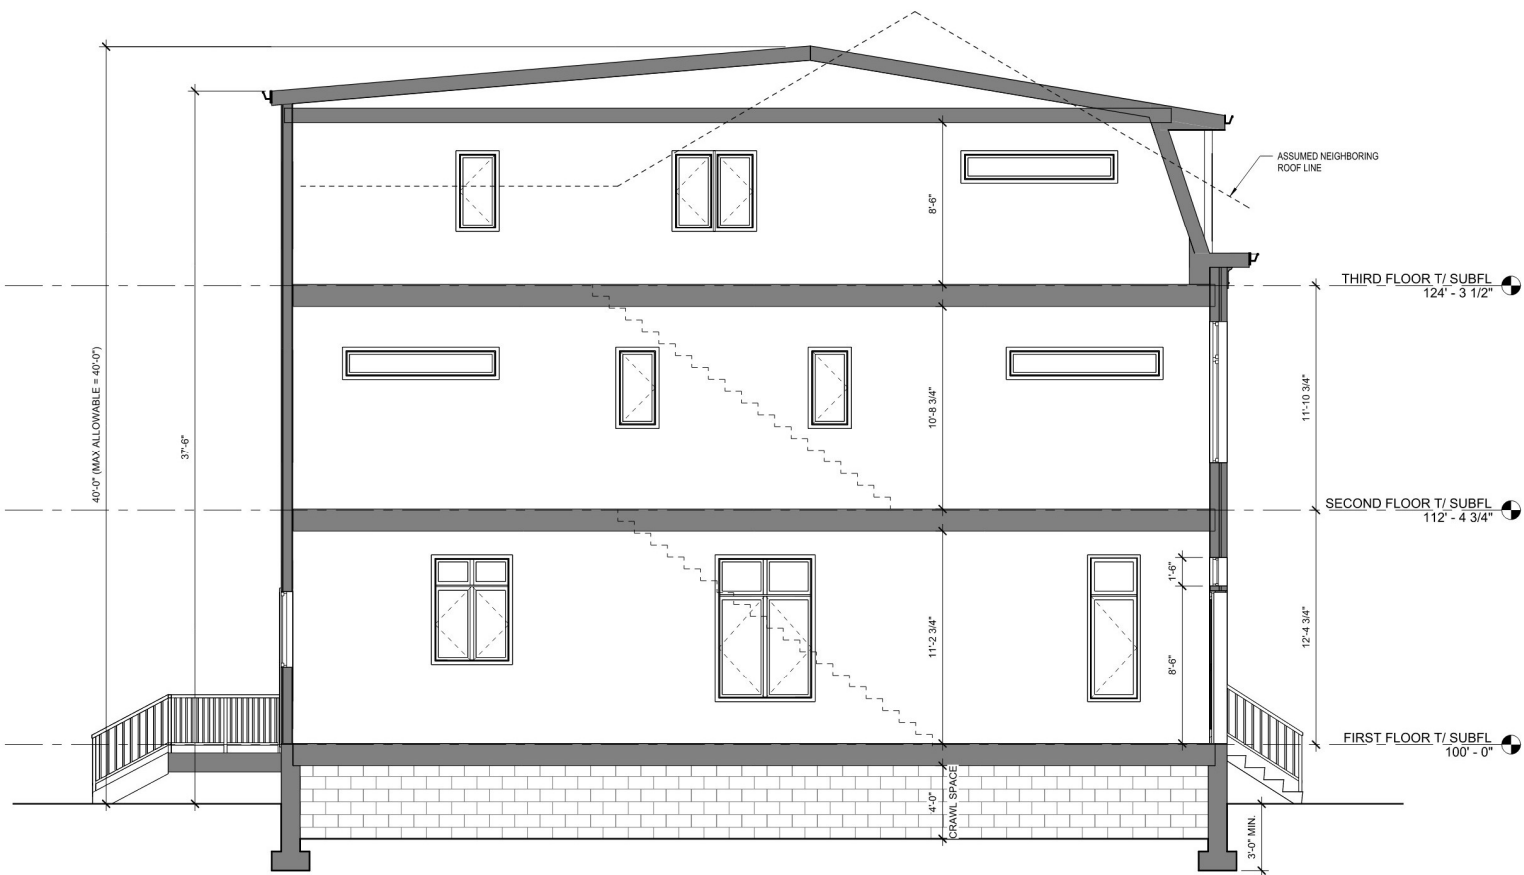
PROPOSED BUILDING SECTION

The diagram below displays how the design of the proposed structure is proportional to the adjacent structures. The overall proportions are slightly smaller than that of the neighboring properties in question due to the width of the proposed footprint being 18'. Overall, the proportions remain within the 10% margin described in the Manchester Historic District Design Guidelines section regarding new construction elevation proportion. These proportions result in a building section w/ approximate floor heights as show (right).

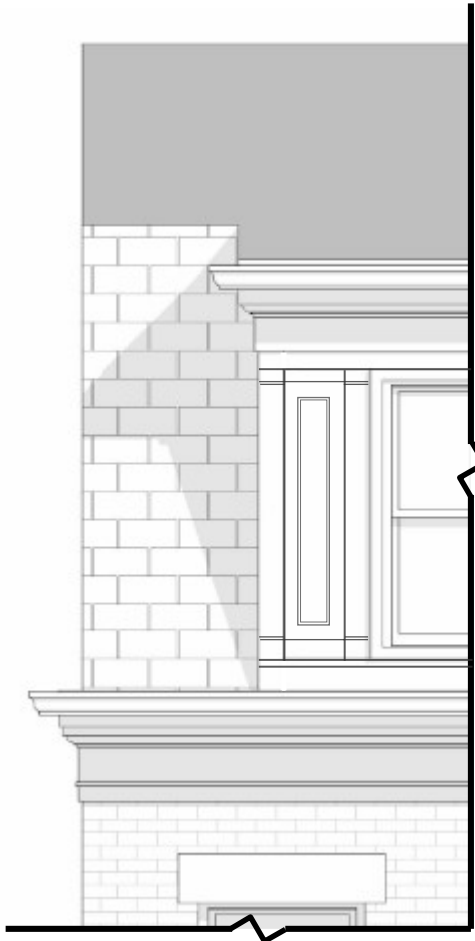
Proposed Structure
DORMER DETAIL
