SCHENLEY FARMS HISTORIC DISTRICT DESIGN GUIDELINES

Adopted December 2025

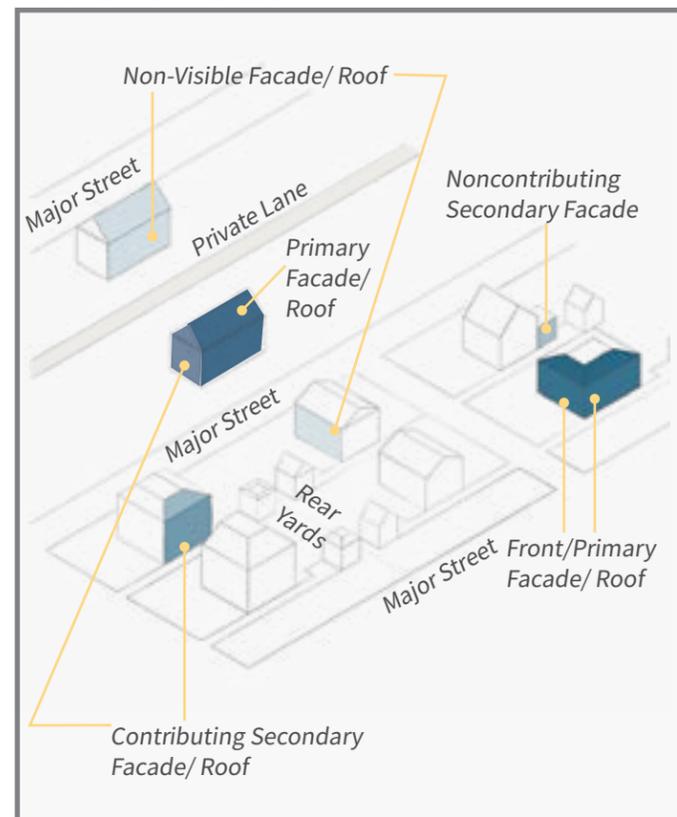
HIERARCHY OF FACADES

In order of importance, the following definitions describe the various façades that are found on a building:

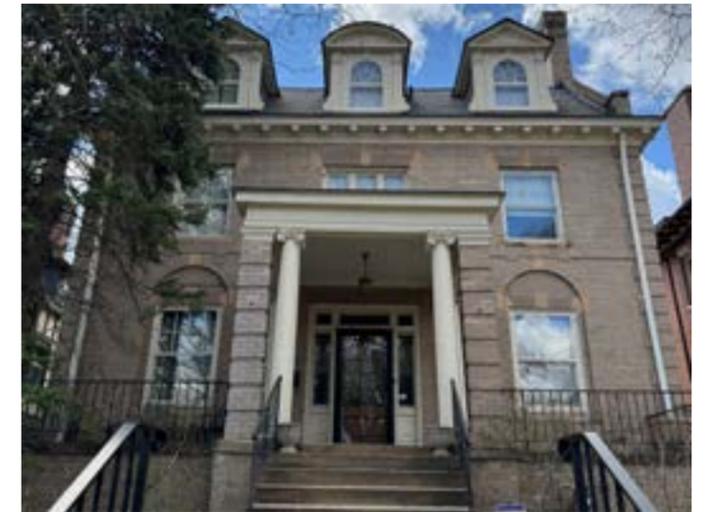
This building is three bays wide, with a central entry and aligned windows and dormers.

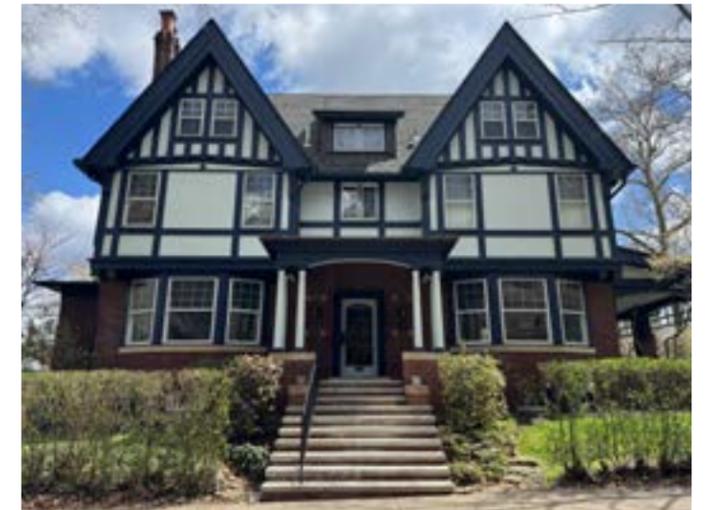
An example of half timber and stucco.

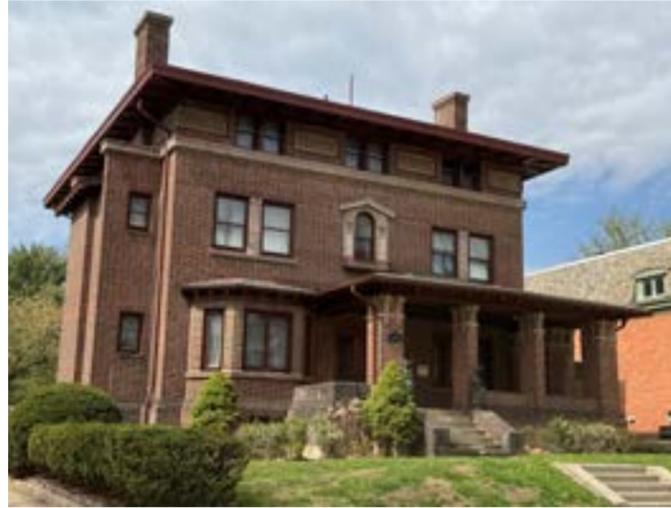
An example of detailed masonry construction.

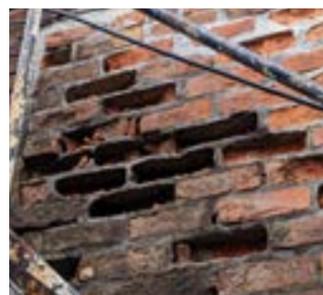
Example of deterioration to masonry caused by inappropriate strength mortar repair.

- 2.1.7 A **qualified person** who is familiar with mortar mixes for historic properties should do repairs and repointing.
- 2.1.8 Portland cement **mortar** is too high in strength for historic materials. A typical compatible mortar is Type N or S, using a combination of Portland cement, lime, and sand.

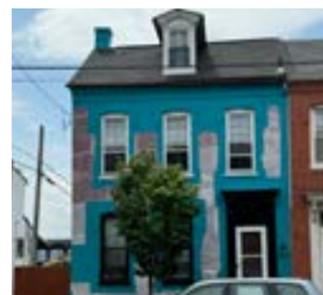
Example of inappropriate use of paint on masonry substrates, as well as inappropriate color choice.

- 2.1.3 Masonry, whether stone or brick, **should not be painted.** These coatings can trap moisture and cause deterioration of masonry walls.
- 2.1.4 **Repainting** may take place if the masonry was painted during the period of initial construction.

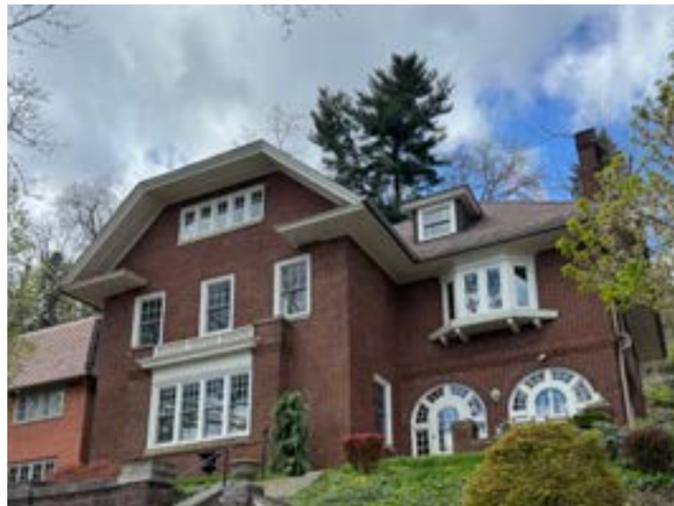
Wide eaves along the gambrel and hipped roofs.

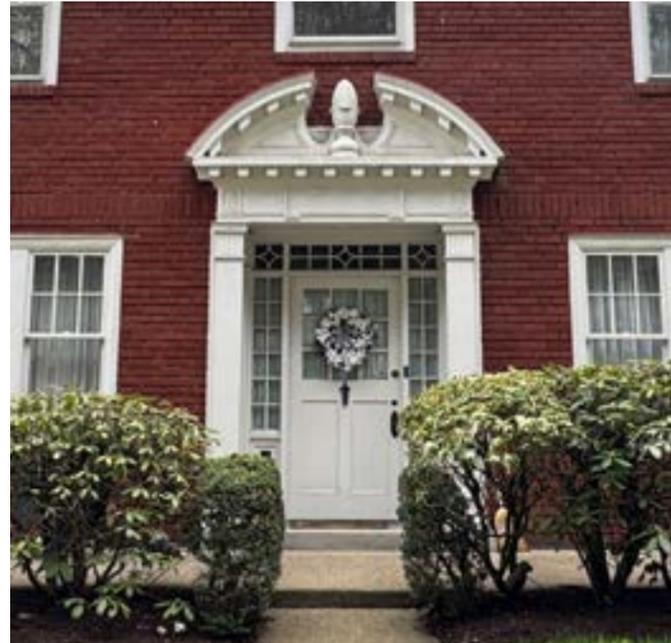
Central entry with sidelights, transom, and pediment surround.

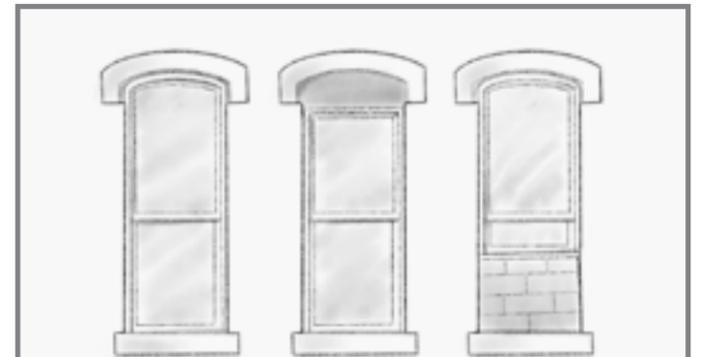
APPROPRIATE INAPPROPRIATE INAPPROPRIATE

Example of an appropriate window replacement approach for existing buildings. The size and proportion of historic window openings should be preserved.

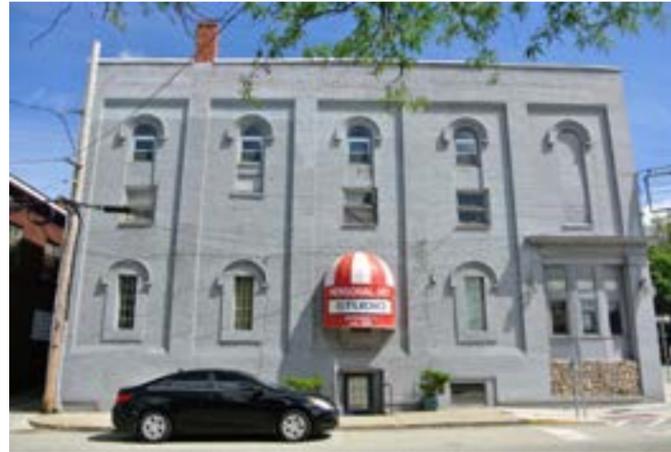
Example of replacement windows that are not appropriate.

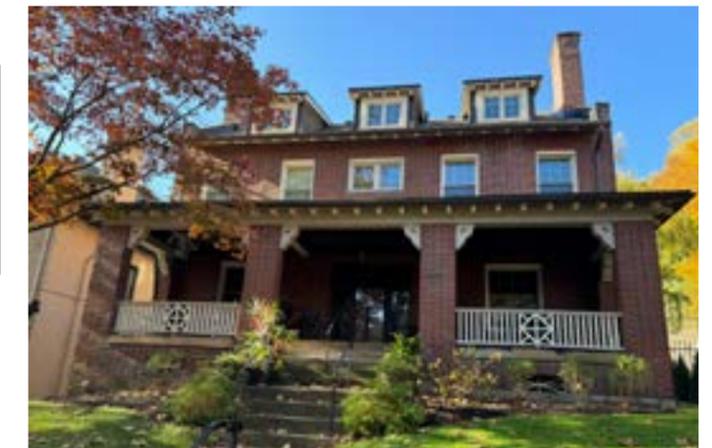
Porches are typically supported by wood or masonry columns.

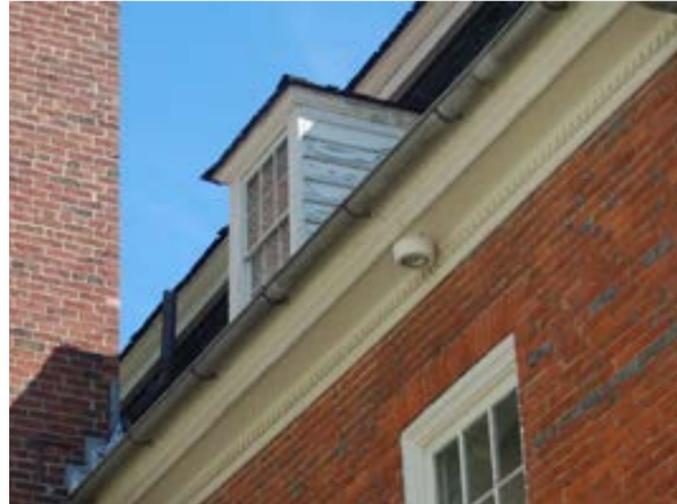
Modern facade lighting is concealed under the eave and the fixture color blends in; this is an appropriate installation.

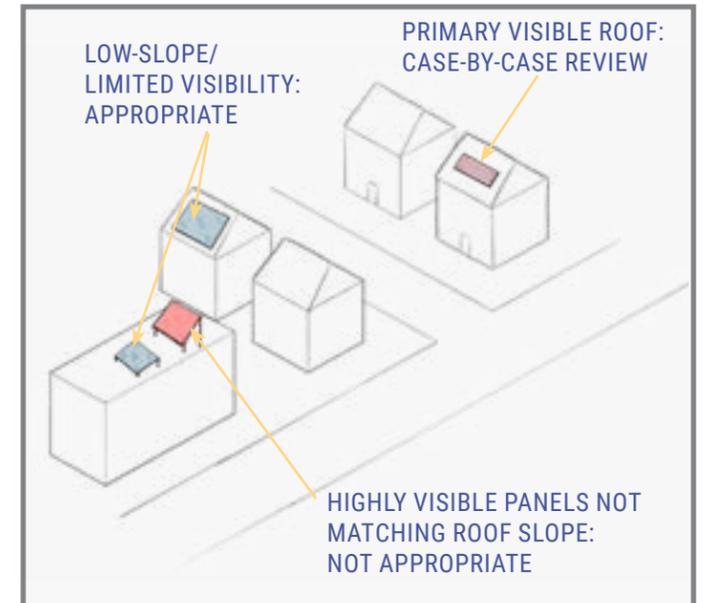
ROOF-MOUNTED EQUIPMENT

KEY CONSIDERATIONS FOR INSTALLATION ON A PRIMARY ROOF SLOPE:

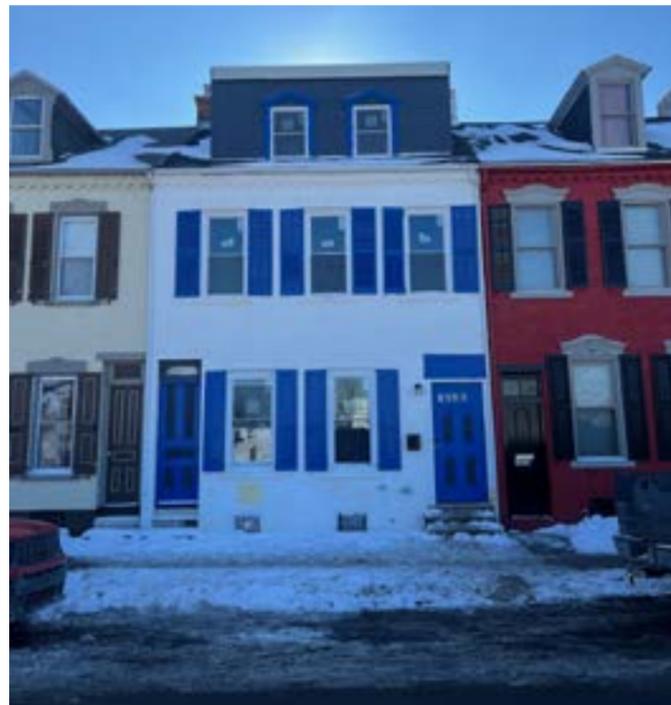
Example of an appropriate dormer addition, which removed an original dormer and created non-historic proportions.

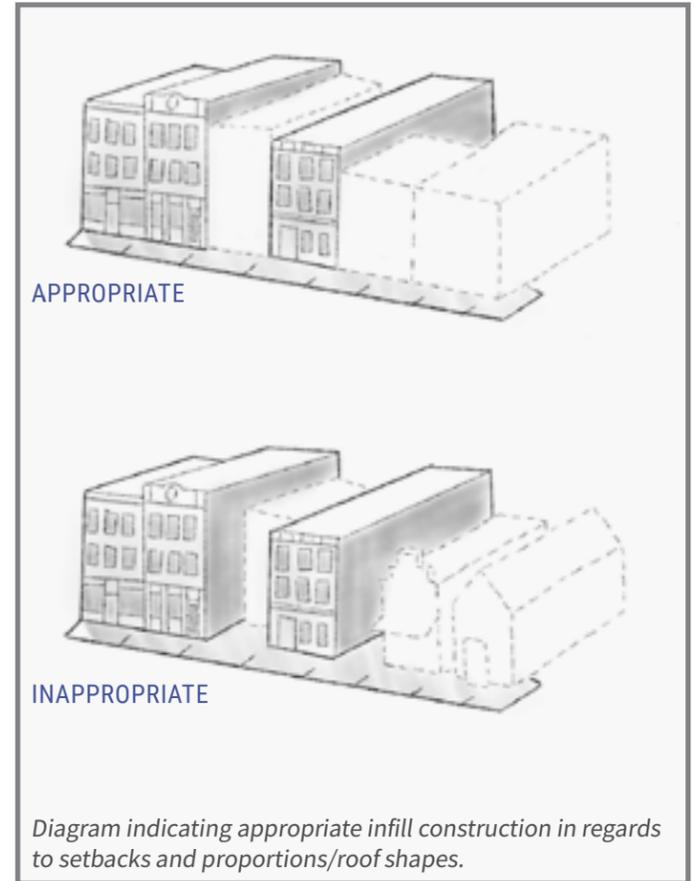
Diagram indicating appropriate infill construction in regards to setbacks and proportions/roof shapes.

- 5.2.1** New construction to **fill existing gaps or utilize vacant or underutilized lots** is encouraged. The design of new construction buildings should be compatible with the existing historic context but differentiated as new construction. This approach will allow the new construction to fit into the visual patterns of the neighborhoods but allow contemporary design, materials, and techniques. Although there are buildings from different time periods in the district, there are unifying features that create cohesive character.
- 5.2.2** Construct new buildings with the same **setbacks** as neighboring structures.
